**Report on the Survey of the Historic Wreck
Located Near the St. Marks Lighthouse**

Underwater Archaeology Research Report Number 3

June 2000

Program in Underwater Archaeology
Florida State University

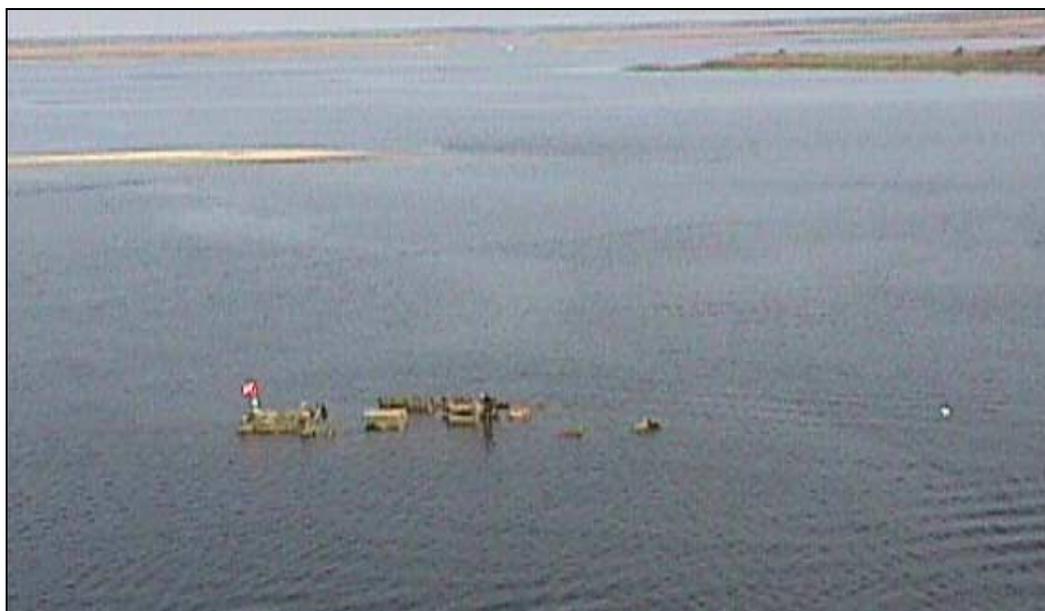
Figure 3: Aerial view of site looking north.

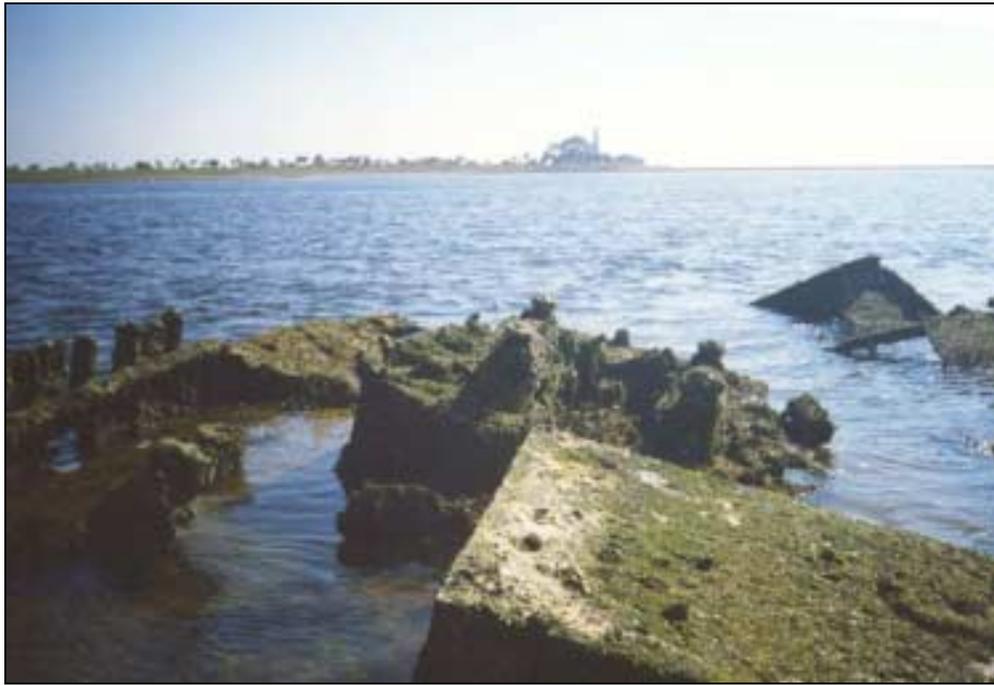
The wreck is covered by rust, barnacles and oyster shells. It lists to the starboard side and the bow faces east at a bearing of 98° , toward the St. Marks lighthouse (see Figures 4, 5 and 6). Most of the deck is completely degraded and many structures have been moved either during the sinking event or during the subsequent salvage of metal and other materials. A baseline was established roughly along the midline of the ship, parallel to the keel. The strong current, during the rising tide, caused the baseline to move, therefore, few measurements were made in relation to the baseline itself. Most measurements taken, due to limited time on site, pertained to the overall vessel form and how large structural features measured in relation to each other.

Figure 4: View toward the bow, facing east toward St. Marks lighthouse.

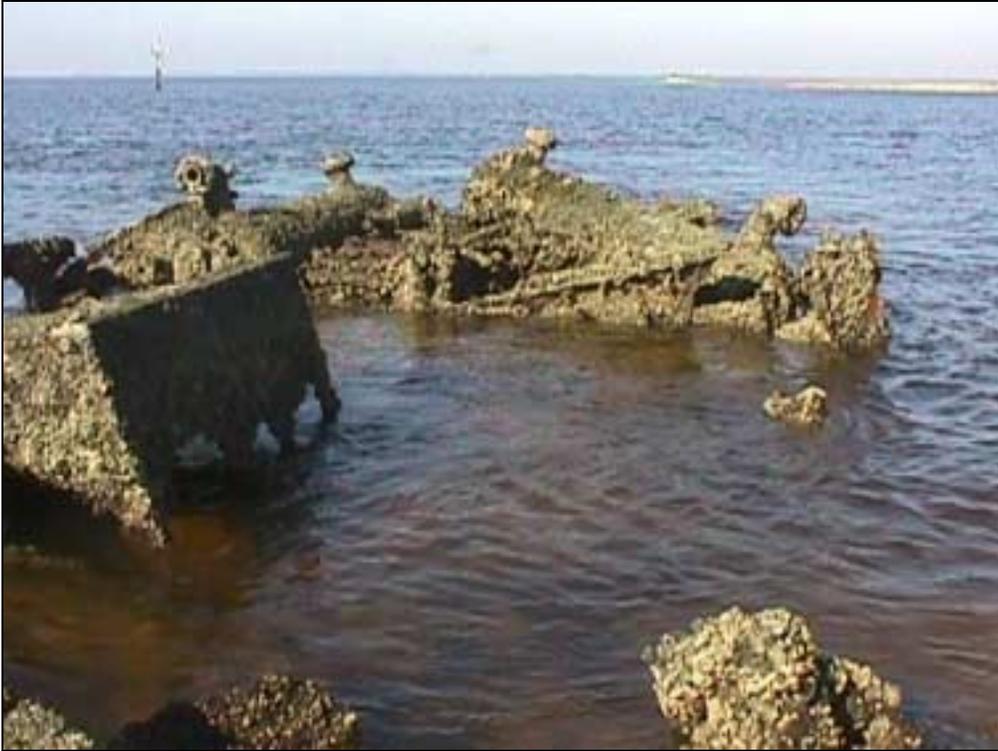
Figure 5: View toward the stern, facing west. Notice channel marker in the background.

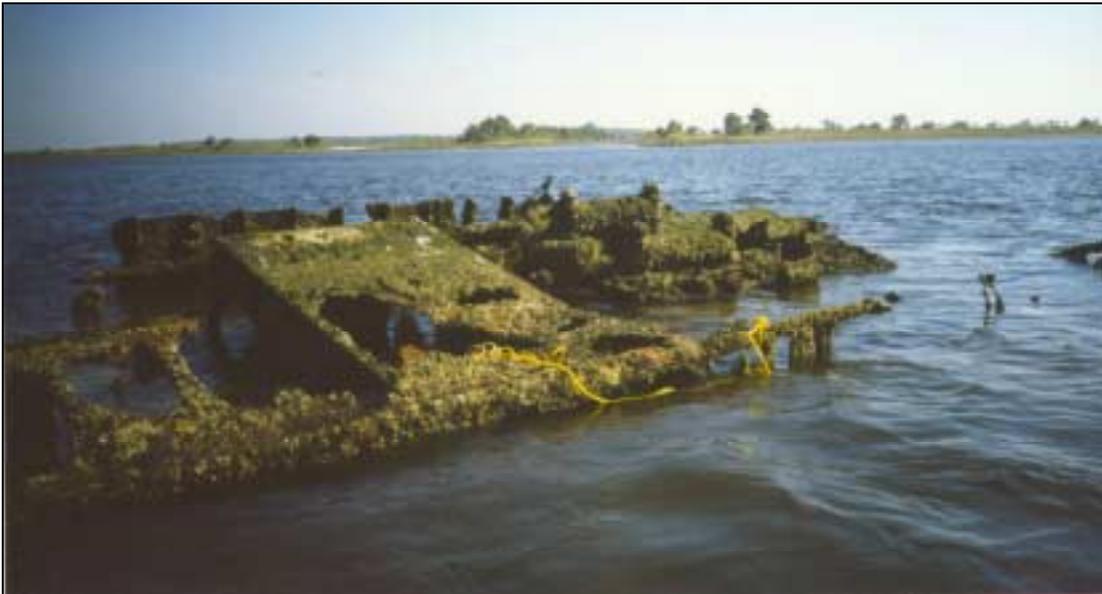
Figure 6: View of the starboard side, facing north.

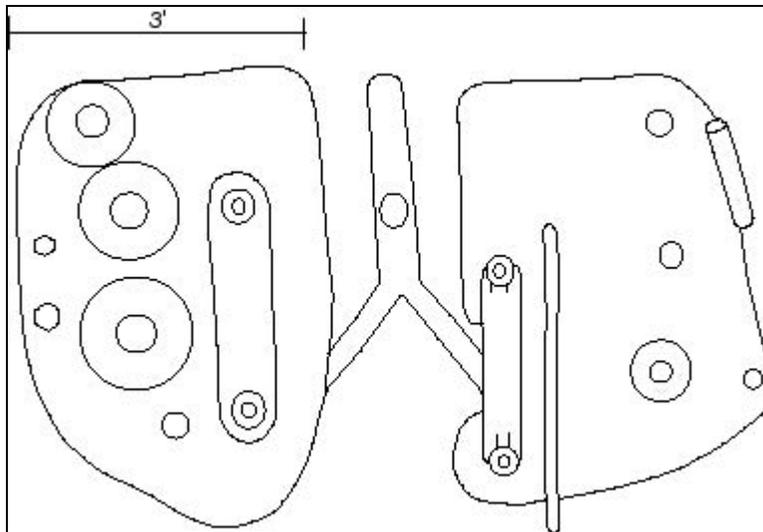
Figure 7: Structure possibly related to the pilothouse.

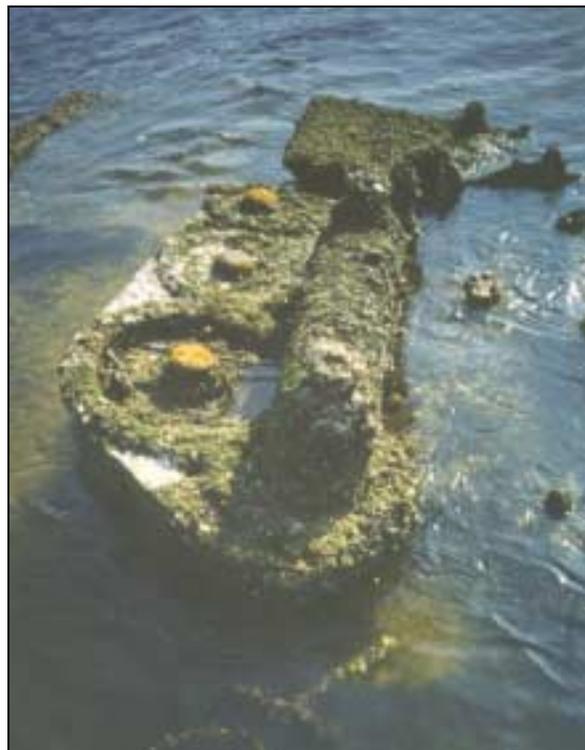
Figure 8: Scanned photo of pilothouse feature (facing 98° East).

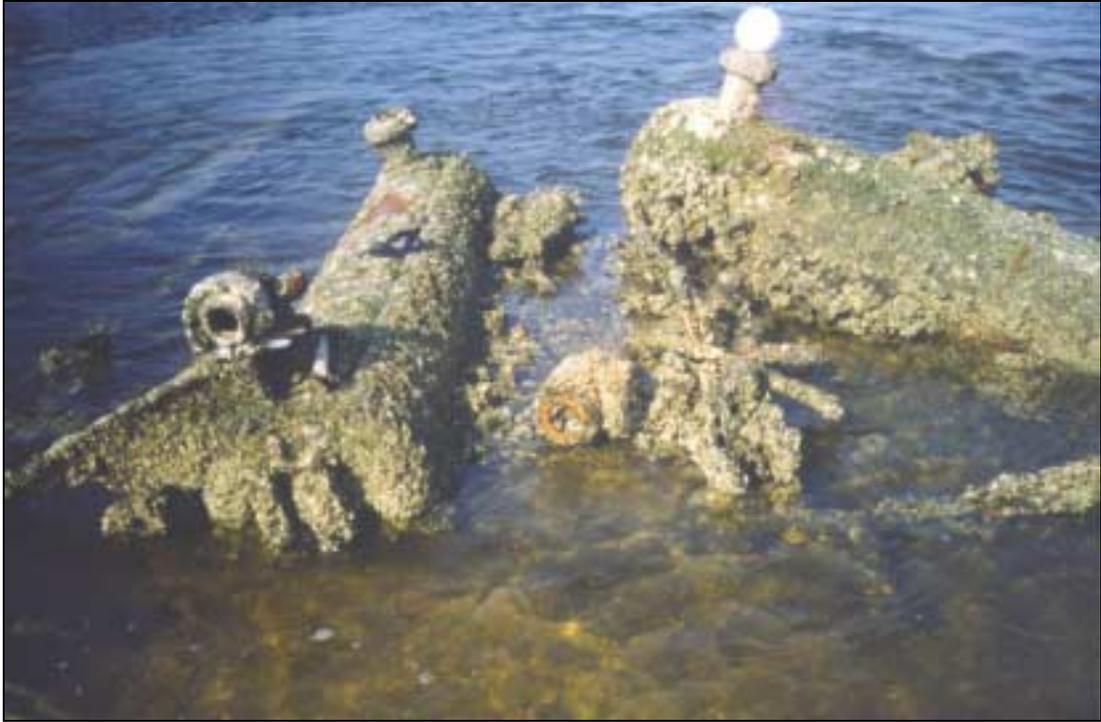
The overall length of the site was determined to be in excess of 144 feet (43.9 meters) while the width, or beam, was 21 feet (6.4 meters). The height of the remaining hull structure, down to the channel bottom, was measured at 8 feet 7 inches (2.62 meters). The bow and stern were significantly damaged and a debris scatter fanned out from each end of the vessel. The bow and stern were easily discernable due to the presence of one complete propeller (minus one propeller blade) and the shaft of a second propeller found mostly articulated with the port side of the hull. The shaft measured 1' 8" (50 cm) in circumference and the blades were 2' 8" (81 cm) in length and 2' (61 cm) in width. The length of exposed propeller shaft was 12' 10" (3.92 meters). Between 18 and 20 meters from the bow, just forward of midship, a structure remains that may be related to the pilothouse. (Figure 7 and 8). Seven meters aft of this feature, two round structures, possibly boilers, rest toward the starboard side of the vessel and measure 9' 8" (2.95 meters) in length. (Figure 9 and 10). They are cylindrical with a diameter of 2' 4" (71 cm).

Figure 10: Scanned photo of boilers.

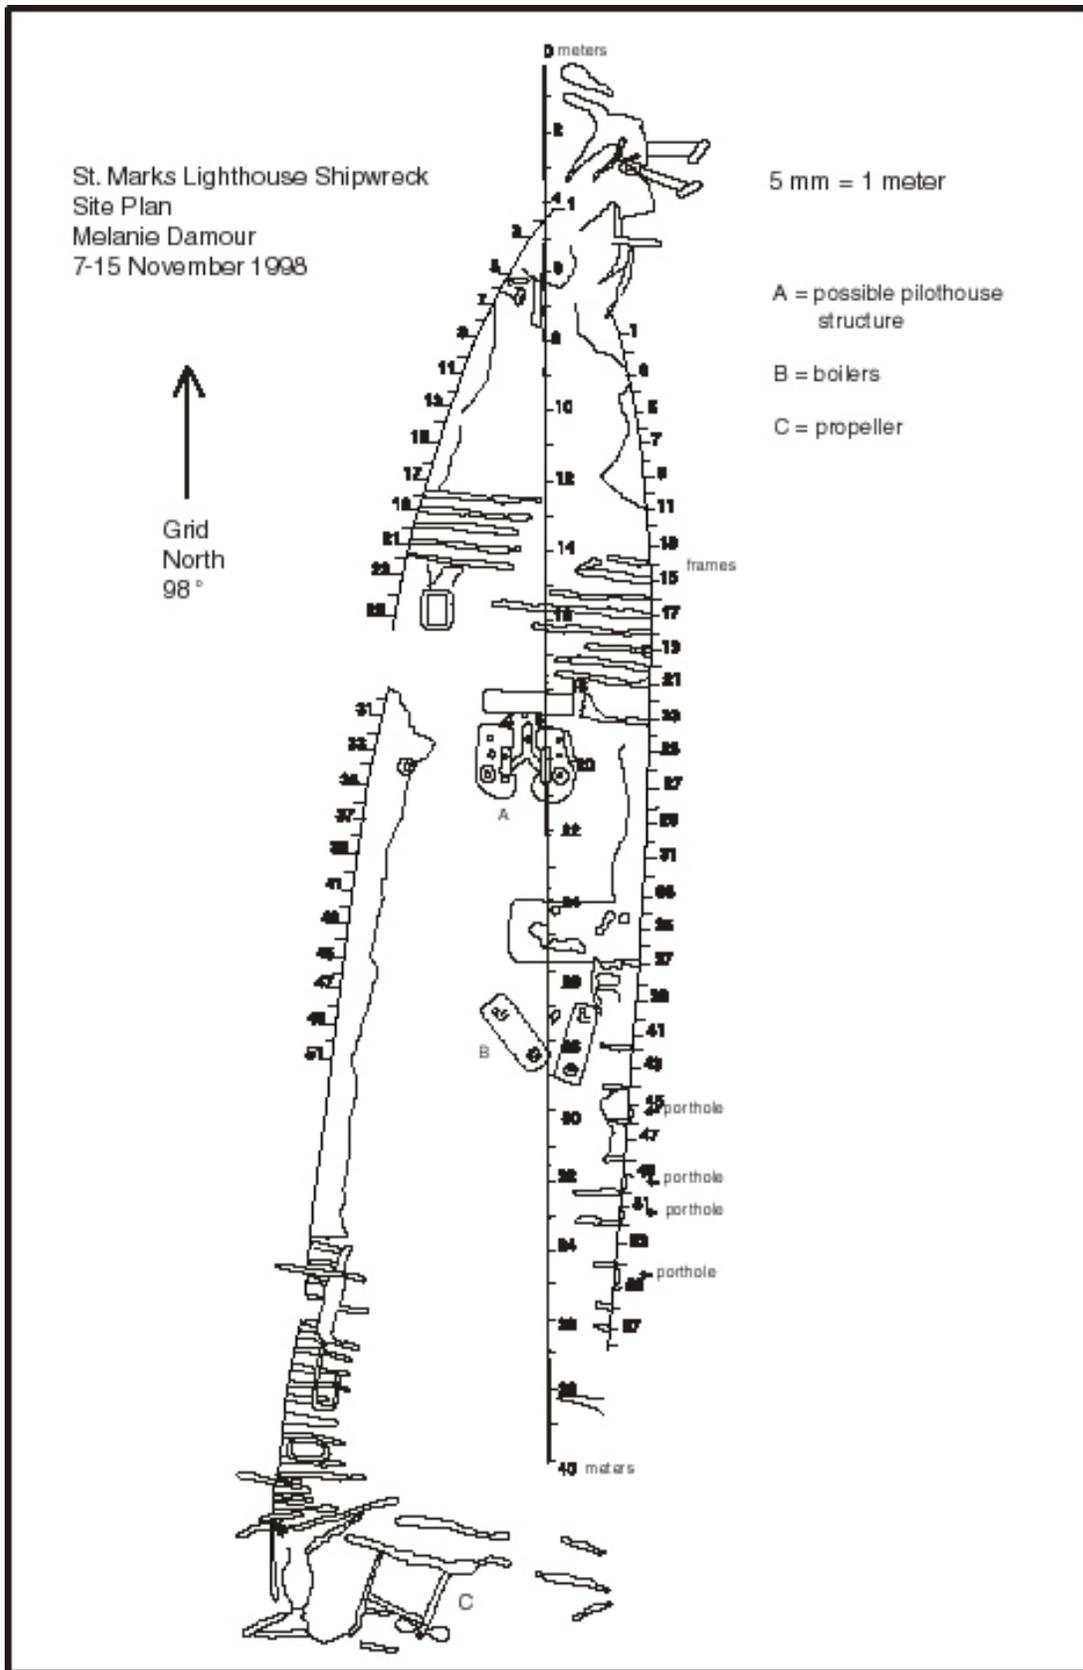
Figure 11: Site map.

A map of the site was produced in order to document the extent of the site as well as structural features that may be utilized for the identification of the vessel, its type of ship construction and provide a record of this unique wreck in Florida waters (Figure 11).
