City of Hawkinsville

Archaeological Assessment

11-February, 2000 to 12-February, 2000

Research Reports No. 10

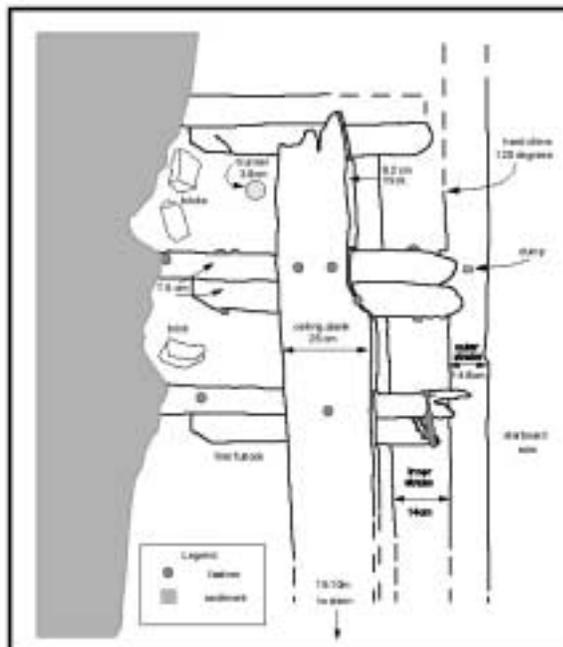
Within the hull structure several pieces of brick were noted. The brick was fragmented and non-diagnostic. The brick appeared to be hand made and from the mid to late 19th century. In addition to the brick, several fragments of wood appeared to be burned. Some of the wood is associated with the brick. Several fasteners are visible and protrude out of the planking. These features were recorded and several photographs were taken of this portion of the wreck.

Figure 1. *Orpheus* planking at amidships

1. Continued examination and survey of this wreck. A mapping program should be implemented in order to determine the actual size of the vessel as well as the extent of the artifact distribution around the site.
2. Continued historical research should also be conducted in order to determine if this vessel is the *Madison* or the *Orpheus*.
3. Encourage graduate students interested in river boats to pursue as a possible research topic.
4. Test excavations may also provide diagnostic artifacts which may help in dating determining the origin of this vessel.

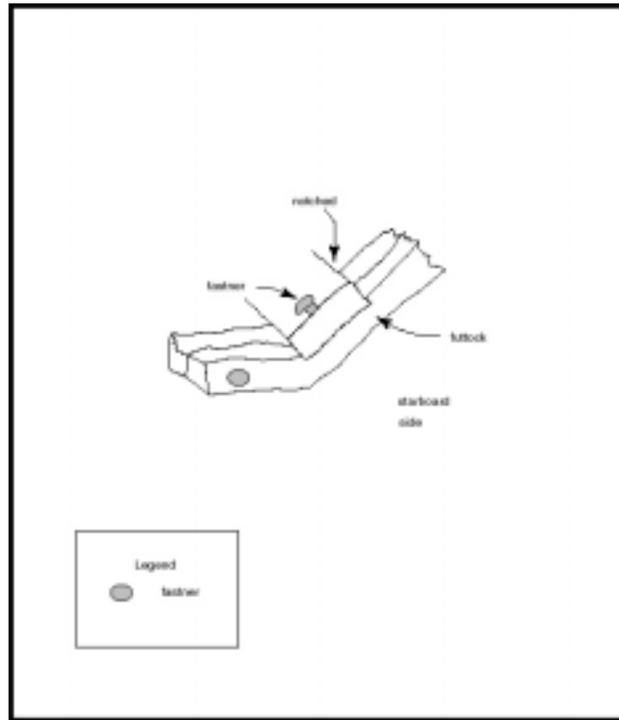
The condition of the sternpost was also noted. After some hand fanning, the bottom of the stern post was exposed revealing that it is rabbeted to the keel of the vessel. The sternpost of the vessel is in good condition and the fasteners that would have held the gudgeon in place are still in place. Measurements of the vessel were also recorded. The vessels length is approximately 34.20 meters with a beam of 5.2 meters. Mapping of a small section of the hull was also accomplished (Figure 1). The first futtock is still articulated with the bottom planking and held together with iron fasteners and trenails. Additionally, the hard chine or angular joint of the hull indicates that this vessel is flat bottomed (Figure 2).

Figure 2. Drawing of Hard Chine of the *Orpheus* (not to scale).

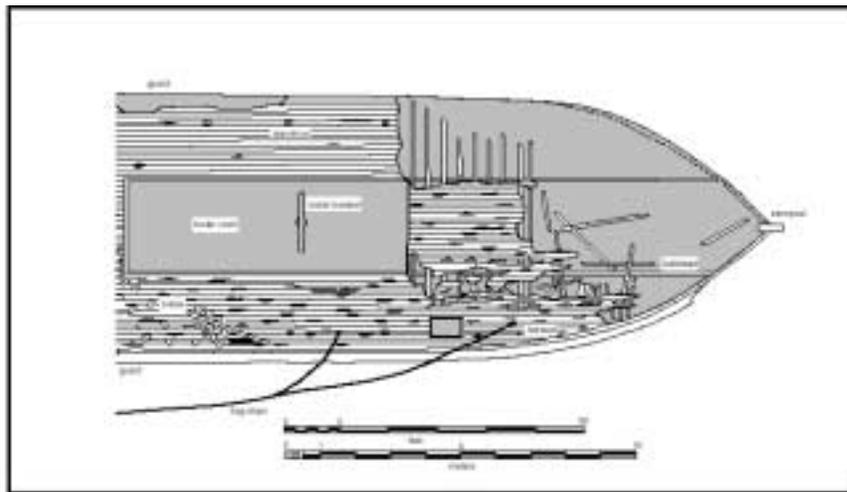
The re-mapping of the bow demonstrates the changes that have occurred to the structure of the vessel over time. Figure 3 is the deck and bow planking as it appeared in 1991. Figure 4 is the current condition of the starboard side of the deck and bow planking in 2000.

Figure 3. Condition of deck and planking of the bow in 1991.

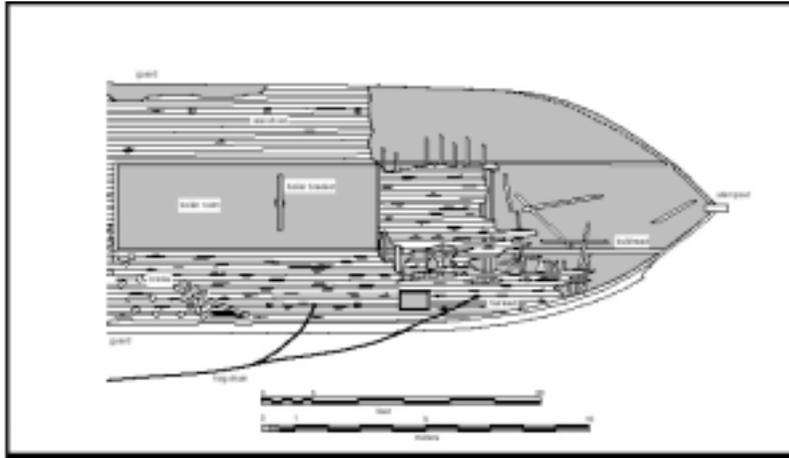
Figure 4. Deck and planking of the bow in 2000.

Continued monitoring is also necessary in order to access the condition of the bow. The current state of the bow is poor and added protection is desperately needed. Some suggestions include constructing a current deflecting device to protect the vessel from snags and other debris as well as the strong currents that occur during age waters (Meide 1999:13). However, until something can be done the bow should be continuously checked and secured so that it does not fall completely apart.
- 4. Florida State University Student participation with the Bureau of Archaeological Research**

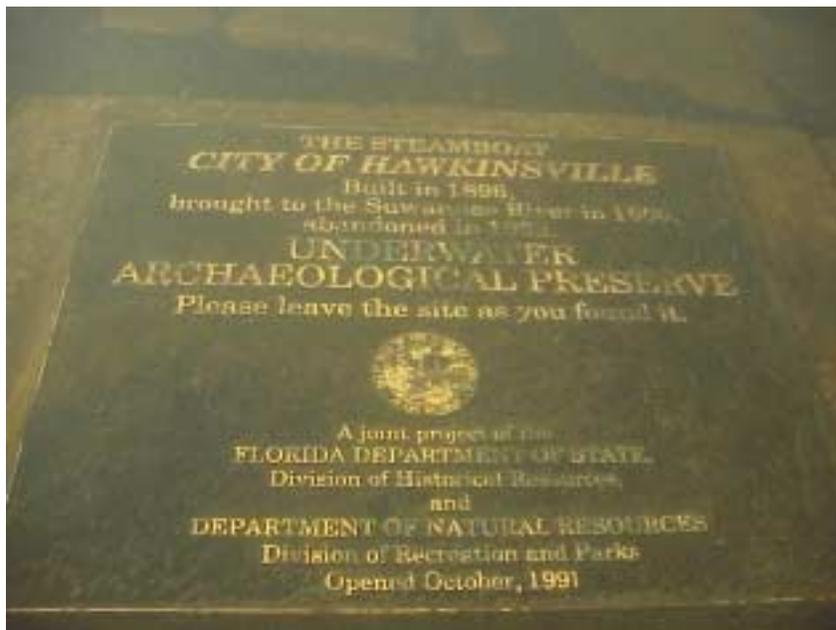
Figure 5. Plaque in boiler room of *Hawkinsville*.

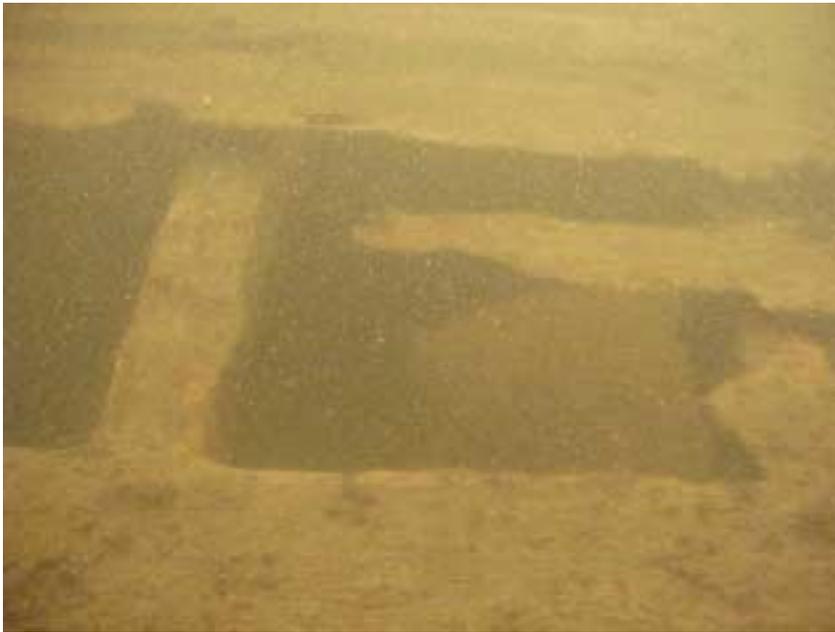
Figure 6. Eroding deck planking near bow.

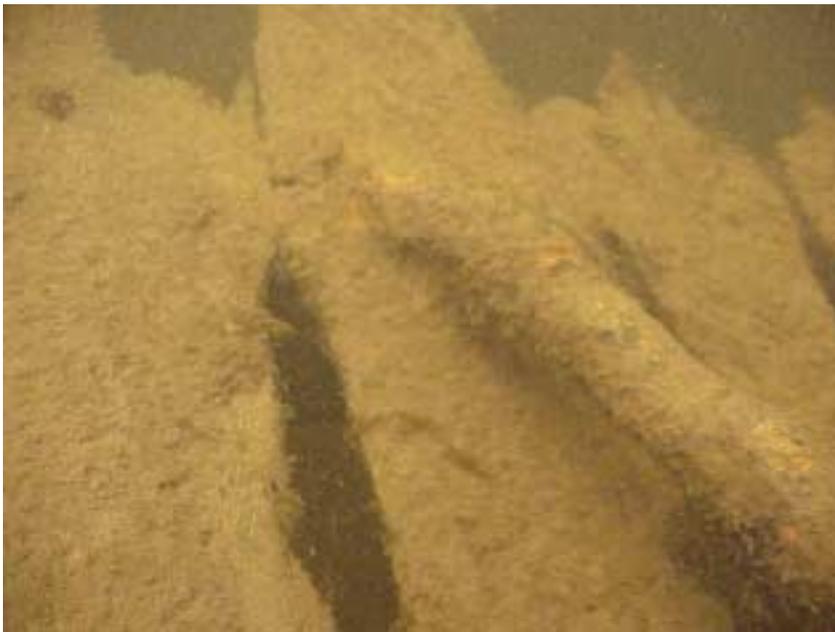
Figure 7. Eroding deck planking near bow with hogging truss attached.
