S.S. Tarpon
2003 Field Report

**Program in Underwater Archaeology
Florida State University
Research Reports # 19**

Whitney Anderson and Julia Giblin

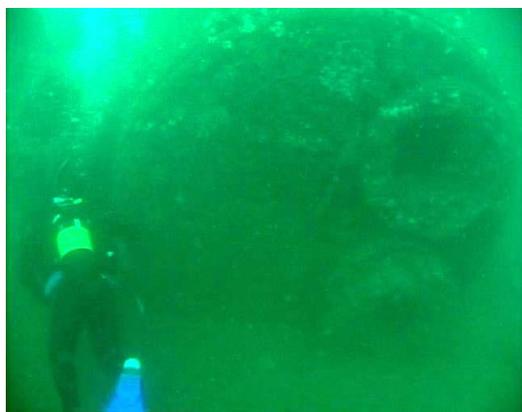
Figure 7 Main Boiler

Mechanical structures on the site including the main boiler, engines, drive shafts and boiler supports seem to have retained their stability since previous surveys and remain relatively intact (figs. 7,10). The starboard propeller is intact under the starboard stern hull plating, and appears to be bent, possibly from the ship's impact with the sea floor after sinking (fig. 9). This feature is unmapped on the original site map. The port propeller was not located.

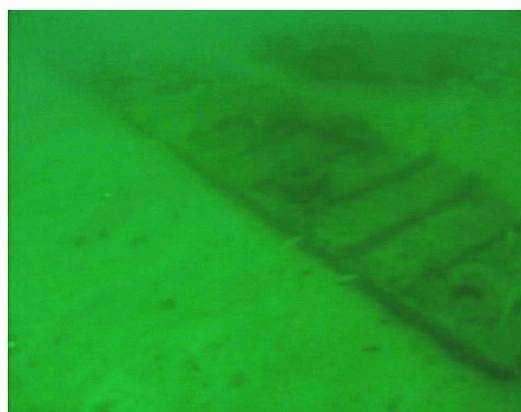
Figure 8 Relocated Hull Section

Several variations in the site layout were noted through a combined study of field notation and video analysis. Dr. Michael Faught noted a greater field of debris scattered near the starboard bow area. He also noted an unidentified circular feature off the starboard bow near the boiler, and a possible hull section off the starboard beam toward the stern of the site. Video analysis of the wreckage revealed that a previously mapped portion of the hull plating off the port bow had shifted position (fig. 8) and relocated next to a section of unidentified plating. A large section of unmapped hull plating was located just aft of these objects, perpendicular to the wreck.

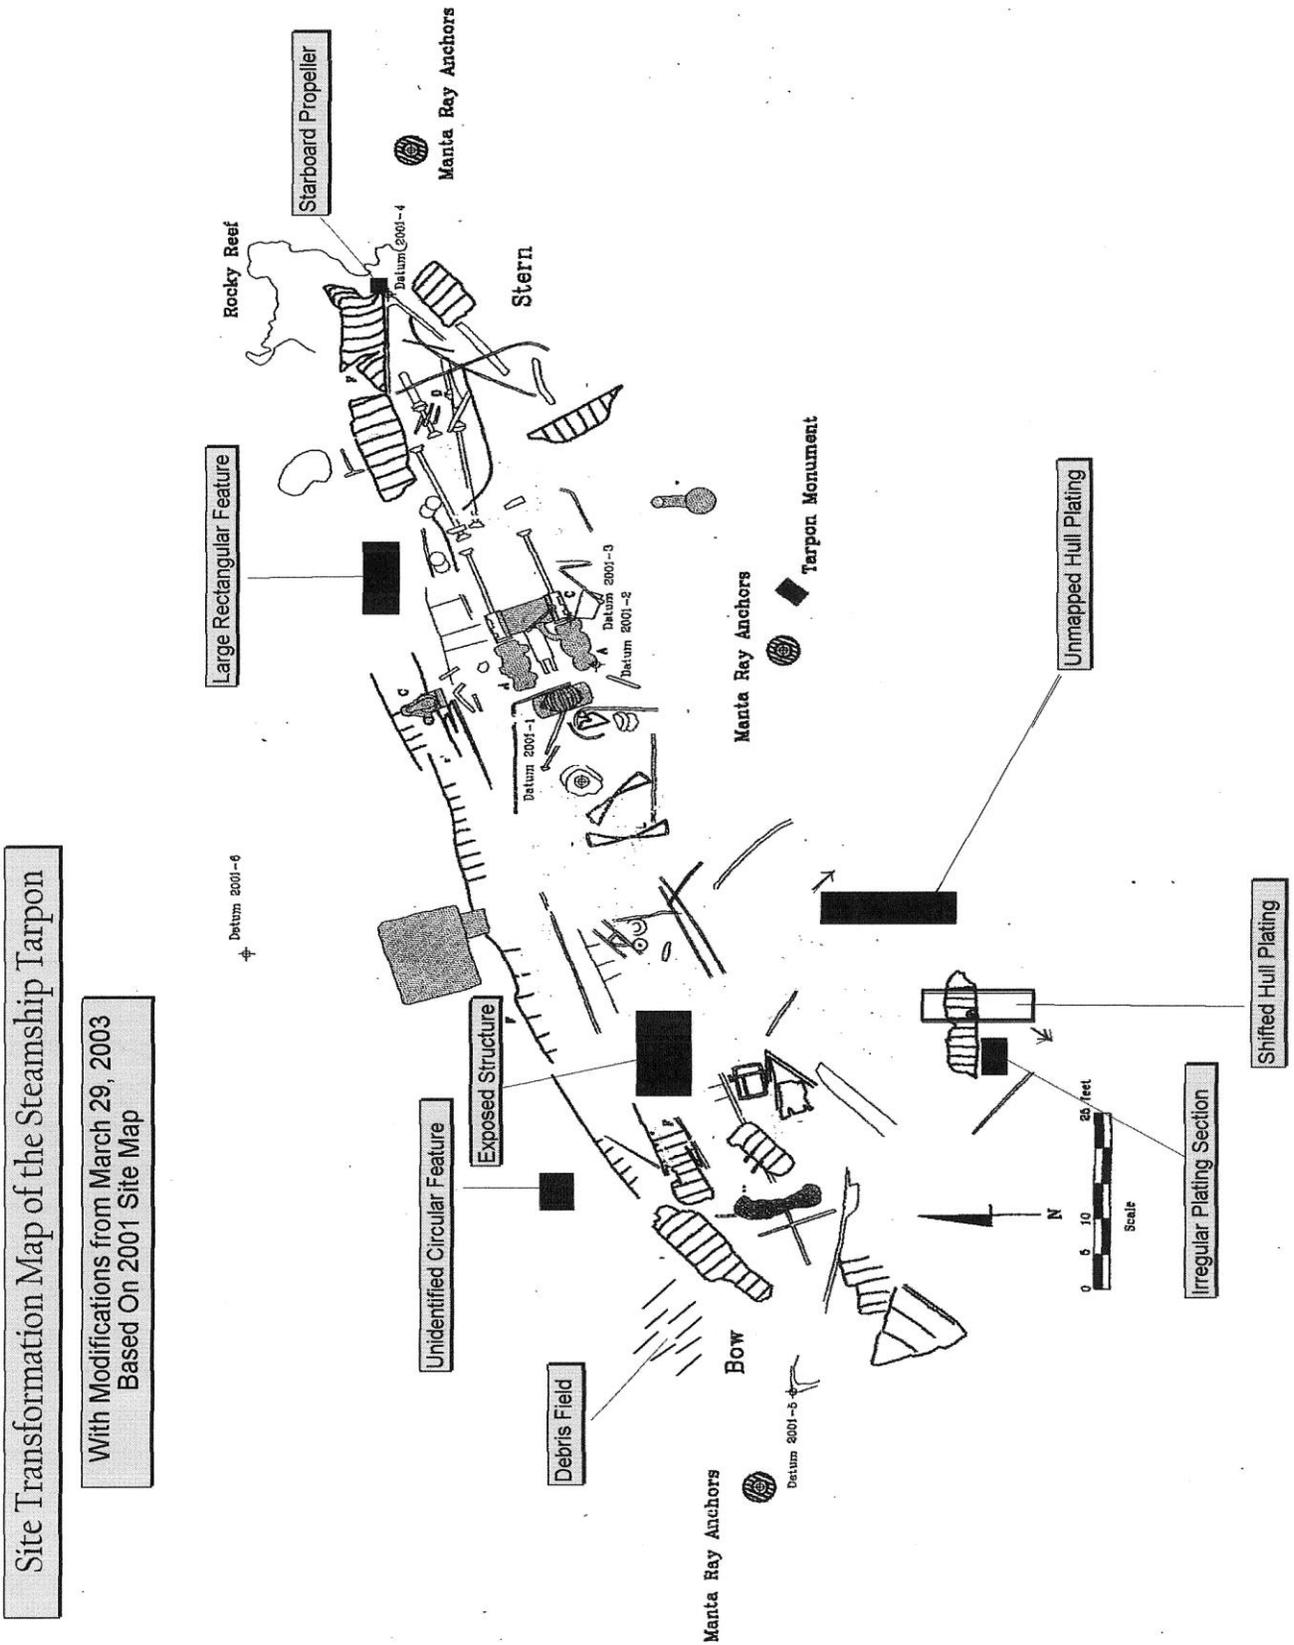
Figure 12 Site Transformation Map of S.S. *Tarpon*

earlier storm, and a large engine component located several feet south of the wreck. Both of these components were recorded on earlier site maps. It was also noted that one of the original propellers was still intact under starboard hull plating. The other propeller was not located. Dr. Michael Faught and Brian Marks conducted a visual survey of the site to attempt to assess any modifications from previous visits. They noted that several features that had previously been covered by sand were now exposed (see fig. 12).

Diver surveys and analysis of video footage both indicated that a greater portion of the site was exposed than during previous research, especially near the bow and anchor windlass. A great deal of unmapped mechanical structure was exposed amidships both fore and aft of the steam engines. Much of this structure was visible but not mapped during the original mapping of the site, however analysis indicates a greater overall degree of exposure of this previously noted structure.

A revised map of the site including more accurate measurements of the new features and possibly greater detail in mapping mechanical structure would be a good prospect for future research as well. A focus on the amount of wood structure remaining as well as a more thorough search for the missing propeller could also be areas of investigation. Continued monitoring of marine life and periodical cleaning and maintenance of the site would help preserve the wreck and ensure a diver-friendly atmosphere.
