Report on the Shipwreck and Biological Survey  
Conducted Near Fleming Key, 17-20 March 1998

February 2001

Archaeological Research Report #7  
Program in Underwater Archaeology  
Florida State University

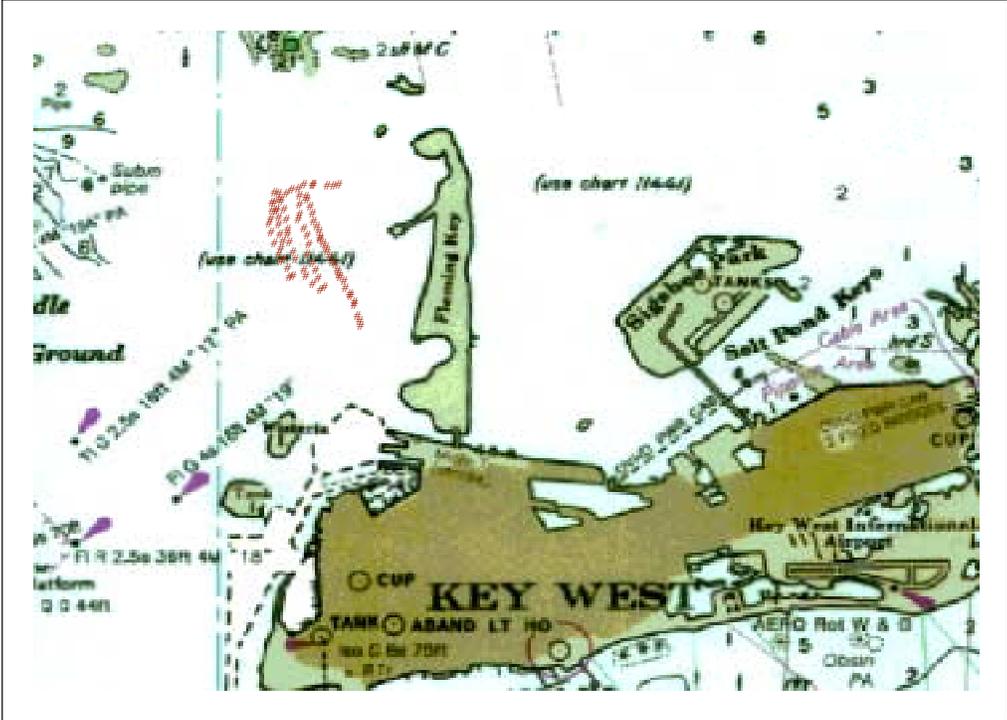
Figure 2: Side scan sonar tracklines from 1998 survey.

1998 Side Scan Sonar Survey Tracklines

A third aspect of this project included the systematic survey of Man of War Harbor and the area surrounding the wreck, utilizing a Marine Sonic 600-kHz side scan sonar. This remote sensing device was deployed on two occasions. First, on 17 March, a survey was

conducted in the Man of War channel. Transect lanes were established along roughly north-south bearings. These results were mixed in their interpretation. There are features in the channel; however, none of the features appear to be shipwrecks, yet, they indicate use or misuse (blast holes from prop washes) of the area. On 19 March, the side scan sonar was deployed around the Fleming Key wreck in order to produce a sonar image of the wreck itself (Figure 8).

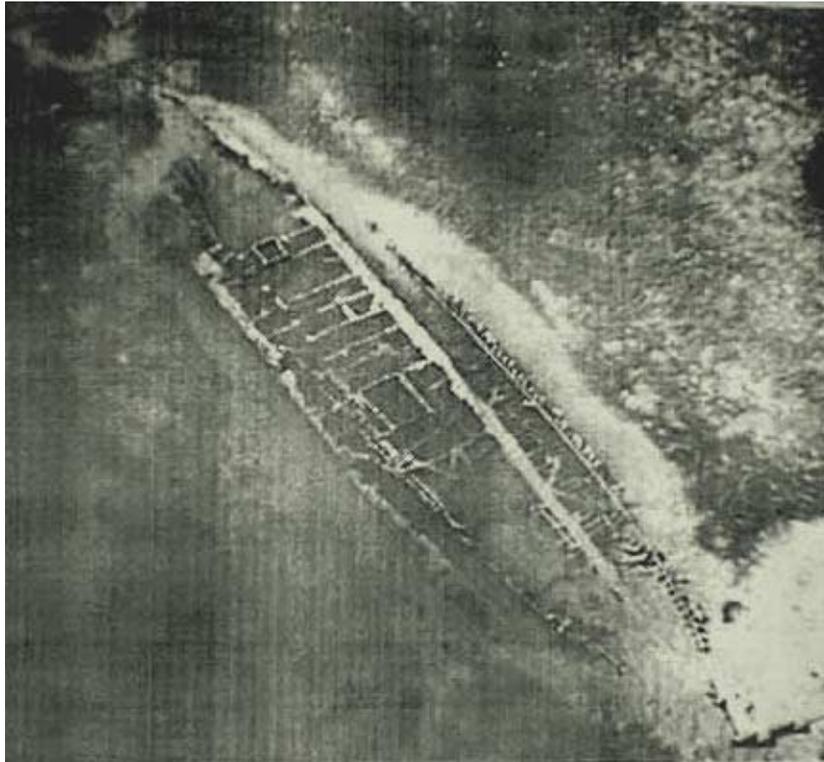
Figure 3: Aerial photograph of the Fleming Key wreck (image scanned from fax).

FKNMS G3001 is located southeast of channel marker #6, on the west side of Fleming Key at 24° xx.xxxx N, 81° xx.xxxx W. The wreck sits in water from three to ten feet deep, sloping downward toward the northern end (Figure 2). It is partially exposed by low tides and metal above the water surface exhibited extreme degradation and exfoliation (Figure 3). The structural members still submerged also demonstrated degradation although they may have reached a state of equilibrium and should not deteriorate much further. Near the southern end of the wreck, two concrete I-shaped structures are located, which may be the remains of some kind of historic dock. The southwest corner of Structure 1 lies at a bearing of 350° from channel marker #5 and 330° from channel marker #6 (Figure 9). The wreck site is popular with local vendors selling skin diving trips as approximately 150 people were observed swimming, standing on, or wading on or around the wreck. These visitors were observed regularly and clearly contribute to the deterioration of the wreck and affect its structural integrity. Perhaps this action alone is enough to warrant a more aggressive management strategy for preserving this historical and cultural resource.

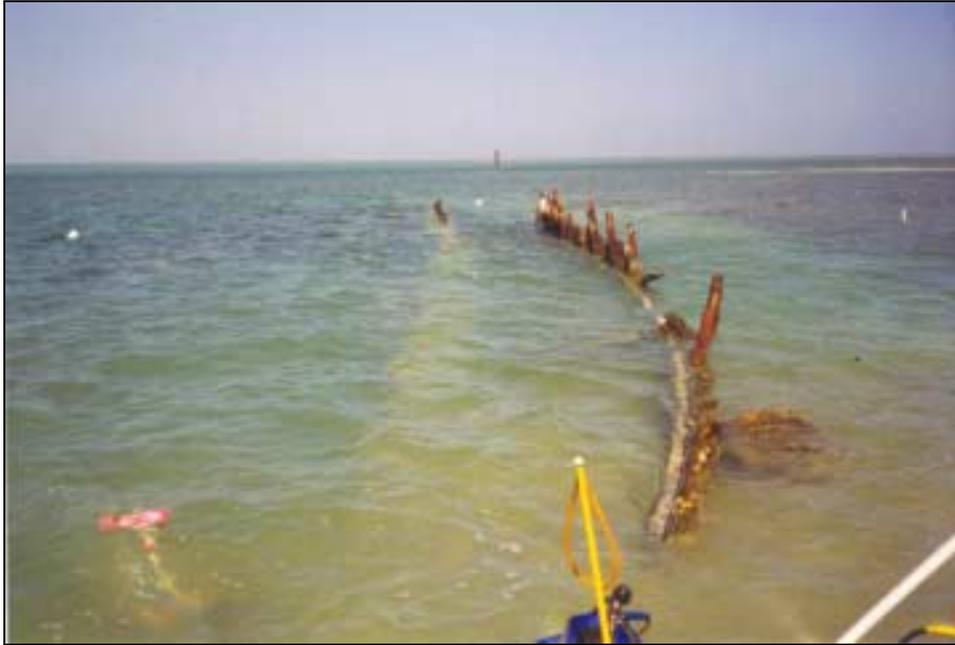
Figure 4: Scanned photograph of the site (looking toward Grid North and channel marker #6).

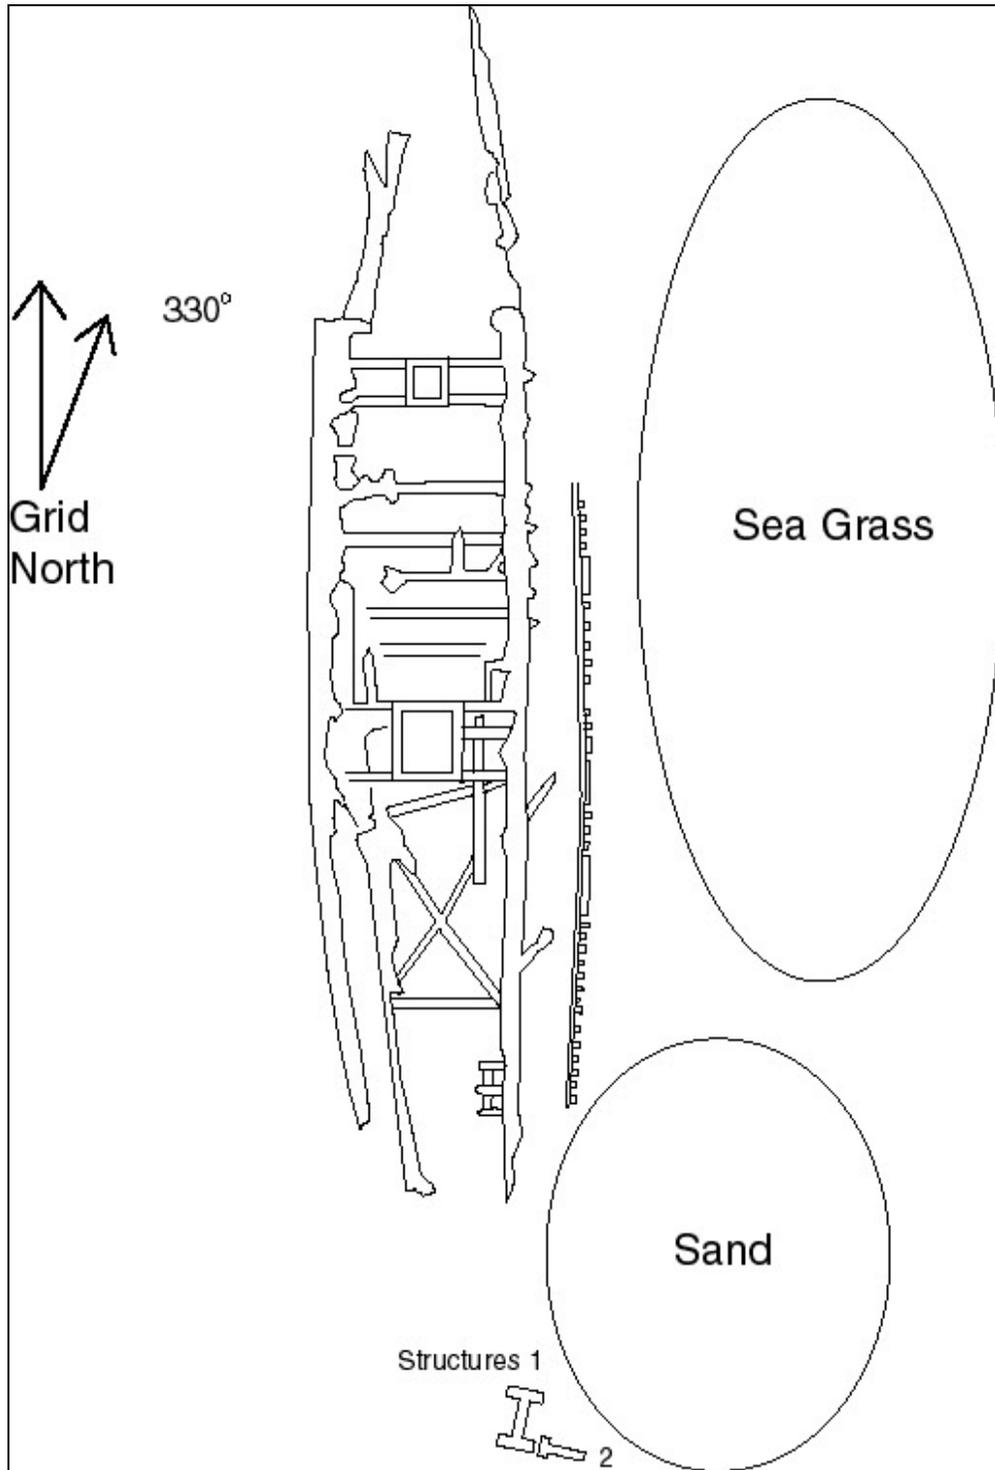
Figure 5: Map of site – facing Grid North (note I-shaped structures at bottom).

Two concrete I-shaped structures were located to the southeast of the wreck and measured. They are included as Figure 5. The length and beam of the wreck were measured, although depth of hold was not recorded. During survey, it was postulated that the northern portion of the wreck was the bow and the southern portion was the stern. Aerial photographs indicated that the ship's length was 167', which was measured at 147' during this survey. Starting at the southern portion of the exposed wreckage, the protruding frames from south to north were labeled as well as other features on the wreck. See Table 2 for all DSM recorded data. Measurements from the aerial photographs indicate a beam measurement of 33' 10", taken north of the area that was measured during this survey. The beam measurement recorded in 1998 was taken at the 26<sup>th</sup> frame at a distance of 36' 1". The distance between frames was between .33 and .38 meters. Exposed frames are prominent on the southeastern portion of the wreck and are non-existent above the waterline on the western side. The ship appears to sit upright in the water and a debris field is scattered a fair distance around the wreck. It was not determined during this survey whether all the materials in this debris field are culturally associated with the wreck.

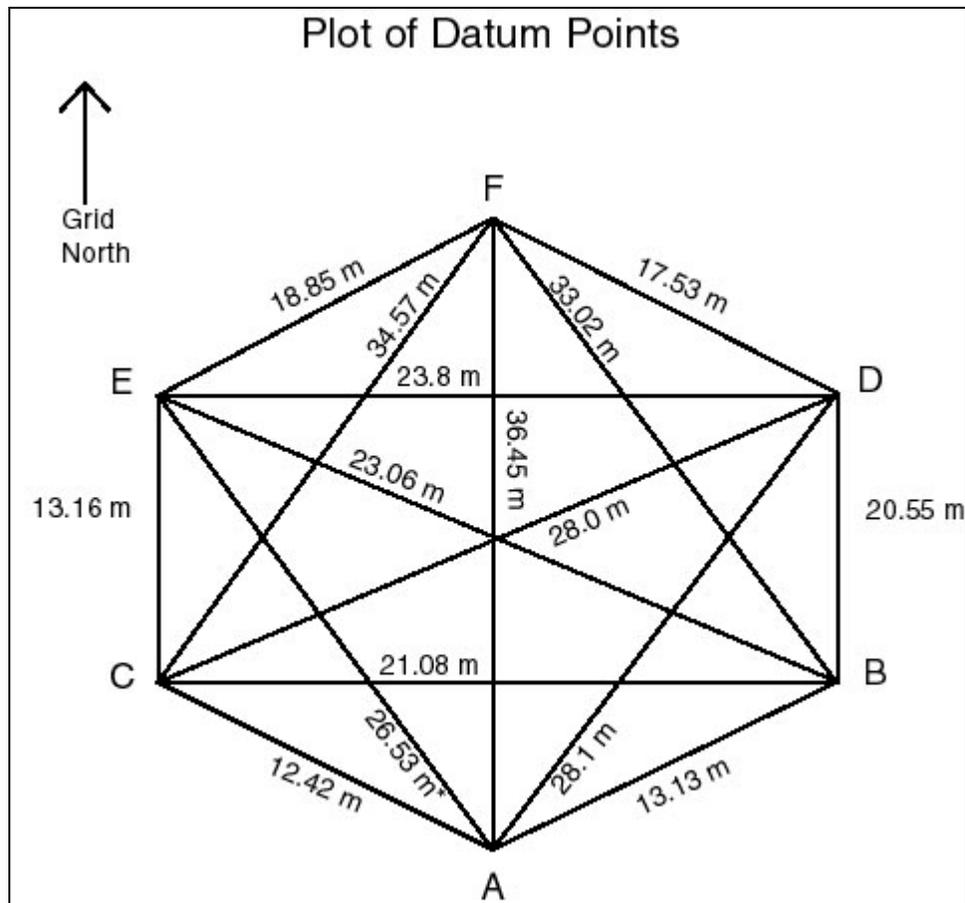
Figure 6: Datum point identification and location (not to scale).

A total of six temporary, moveable datum points were placed around the wreck and designated as A, B, C, D, E and F. Each datum consisted of a PVC pipe attached to a plastic laundry basket, weighted down with a 50-pound bag of concrete. Attached to each PVC pipe was a measuring tape, from which all direct survey measurements (DSM) were taken. Before fieldwork, data collection sheets for recording DSM were produced from Mylar waterproof paper. Each day, collected data was entered into a computer, using the “Web” program, and a map of the wreck was produced. The computer requires that all interdistances, the distance between the datum points, be entered first in order to determine where all the datum points are in relation to each other. Once this has been established, the computer can determine where all plotted measurement points lie in relation to the datum points. Once all datum points were measured and tapes were attached, each datum point’s location was fixed using a Trimble NT200D GPS unit from the side scan sonar. Once the positions were fixed with the GPS, the distances between the datum points were measured and are as follows:

A/B	13.13 m	B/F	33.02 m
A/C	12.42 m	C/D	28.0 m
A/D	28.1 m	C/E	13.16 m
A/E	26.53m *	C/F	34.57 m
A/F	36.45 m	D/E	23.80 m
B/C	21.08 m	D/F	17.53 m
B/D	20.55 m	E/F	18.85 m
B/E	23.06 m

The depth below surface of the measuring tapes on each datum point was also recorded on 19 March at approximately 0945. The tidal conditions for 0930 and 1000 were just below the mean tide for the day, which was about 1.0 ft; conditions were .8 and .9 ft. respectively. The depths of the tapes below the water surface is as follows:

A	21 cm
B	0 m
C	2.21 m
D	9 cm
E	91 cm
F	2.05 m

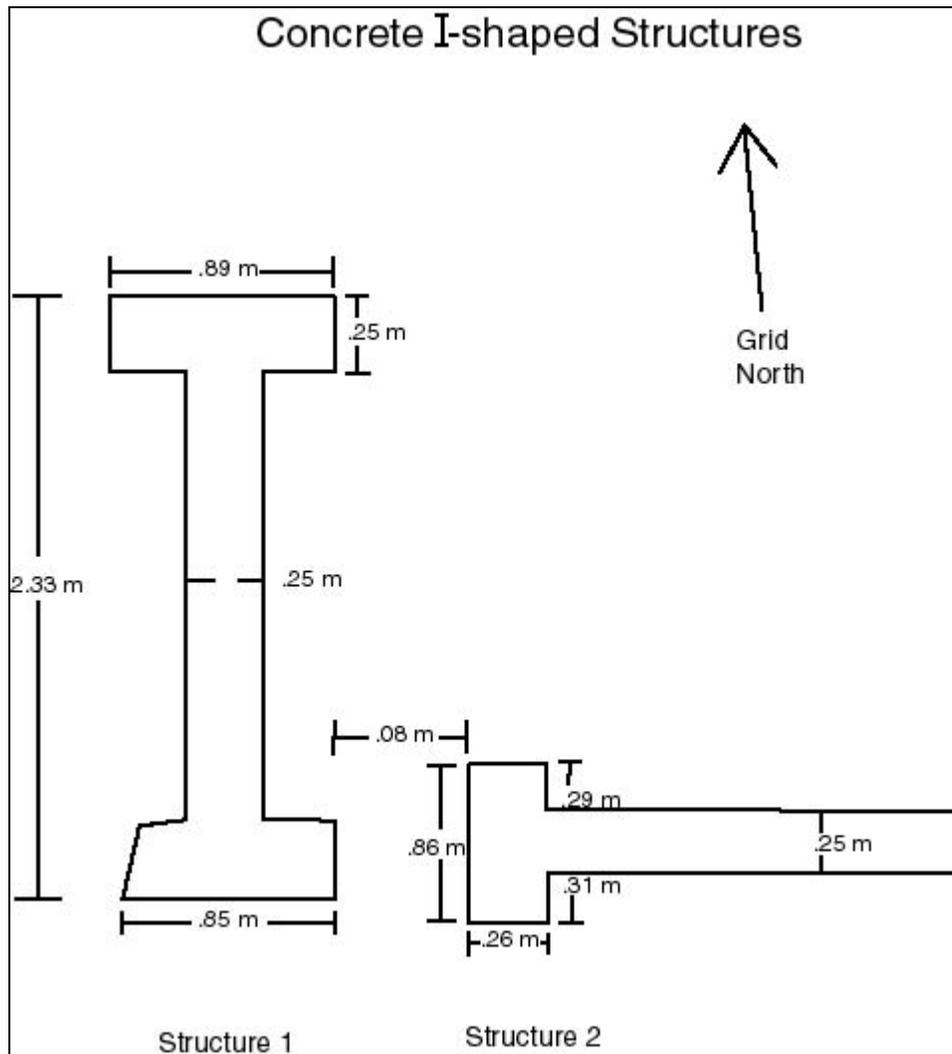
Figure 7: Drawing of possible concrete dock feature (not to scale).

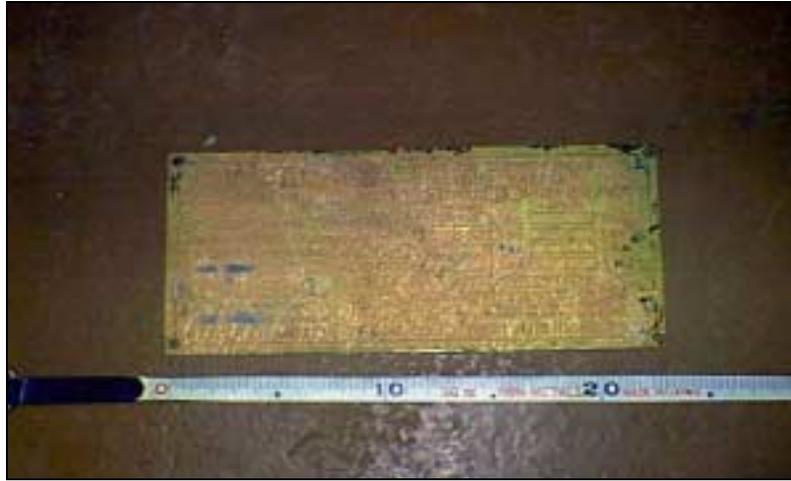
Figure 8: Copper plate.

Only one diagnostic artifact was analyzed, giving a date, which has not been unequivocally associated with the wreck. A copper plate, measuring 9.8 cm by 23.4 cm, was recovered on the northern portion of the wreck by Mark Butler and was cleaned and analyzed by Elizabeth Kamerick (Figures 6 and 7). The plate bears the insignia of the U.S. Navy and the name of the Federal Motor Truck Company, Detroit, Michigan, USA. The plate relates warranty and usage information about a truck transmission that was later located. The patent numbers are 885986 (28 April 1908) and 921963 (18 May 1909). While an association between the plate and the shipwreck cannot be stated unequivocally, the dates on the plate and the form of ship construction seem to be relatively contemporaneous. The combination of a boiler and mast suggests a ship that combined both sail and steam propulsion.

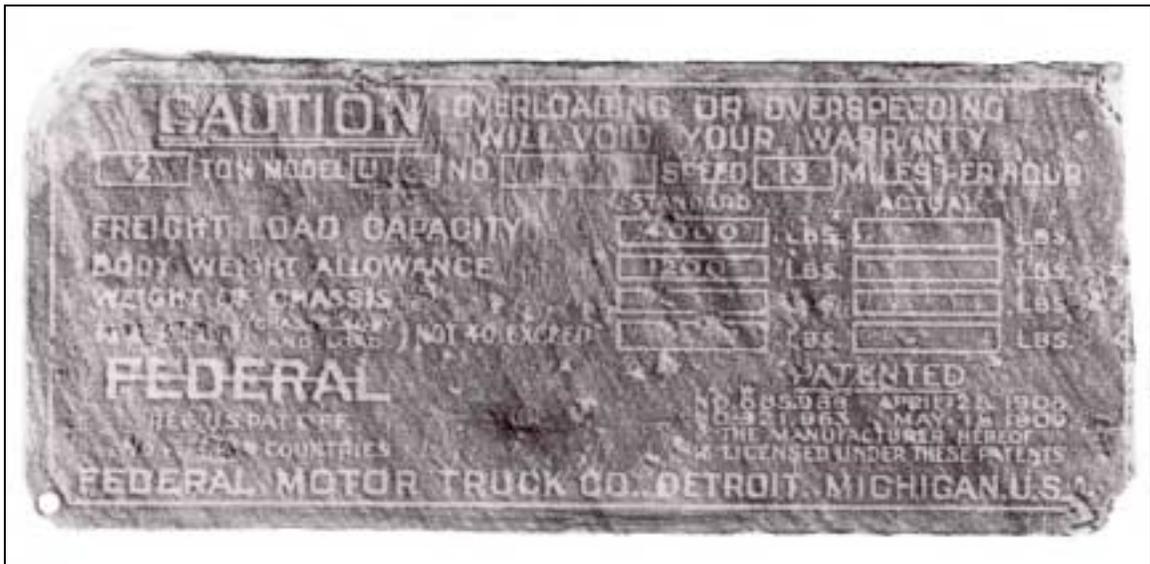
Figure 9: Scan of pencil rubbing of copper plate (not to scale).

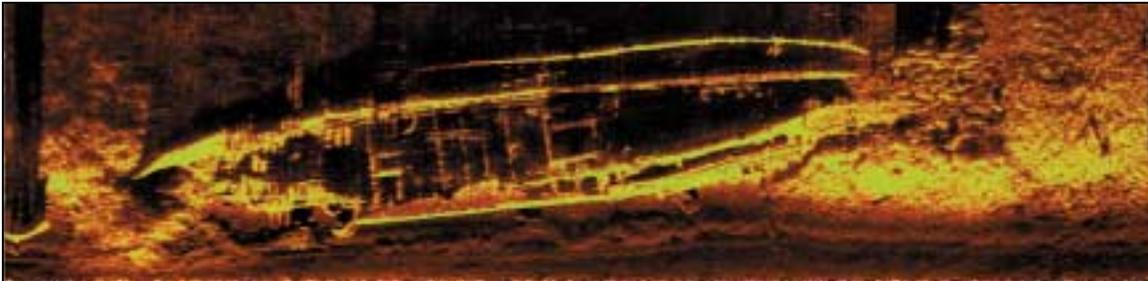
Figure 10: Side scan sonar image of Fleming Key wreck (looking east).

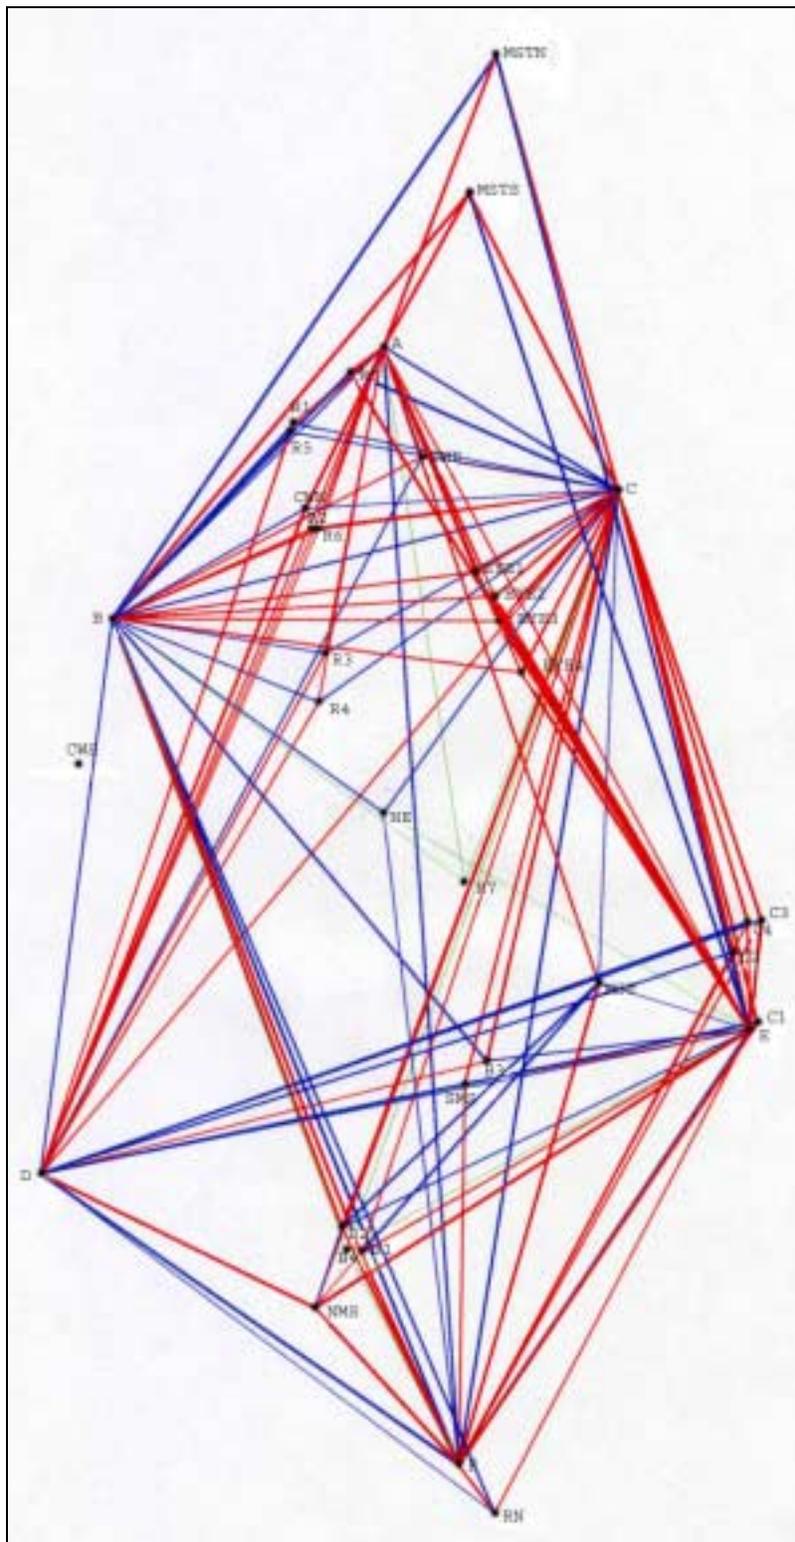
Figure 11: Web program constructed image of Fleming Key wreck and datum points.

The Web program constructed lines between measured points based on distances entered into the program. The green lines represent distances that are within a tolerance level that was autobalanced by the software (roughly 1/2 meter). Blue lines represent measurements that are too near (relative to the surrounding measurements) and red lines represent measurements that are too close. Thicker lines also demonstrate decreased accuracy based on algorithms within the program.

In order to map the wreck, an innovative method, using the “Web” program developed by Nick Rule, was employed. The Web software builds and verifies spatial relationships between components of a wreck and specified objects located nearby. Version 3.12 (1992) was used for this purpose. The distance and depth data recorded daily was entered into the program, which constructed a multi-lined web that described various features of the shipwreck. The program iterates on the entered raw data to perform adjustments to each datum point and direct distance measurements in order to arrive at a more accurate spatial relationship. Web operates by using at least four datum points to locate and record any point on a site. By using four points, there is three-dimensional control of the map produced from the direct survey method (Appendix – Figure 10 and Table 1).
