**City of Hawkinsville Archaeological Assessment
Suwannee River, Old Town, Florida
February 24, 2001**

Research Report #11

**Florida Bureau of Archaeological Research and
Florida State University Program in Underwater Archaeology**

**Field Report by:
Brian Marks**

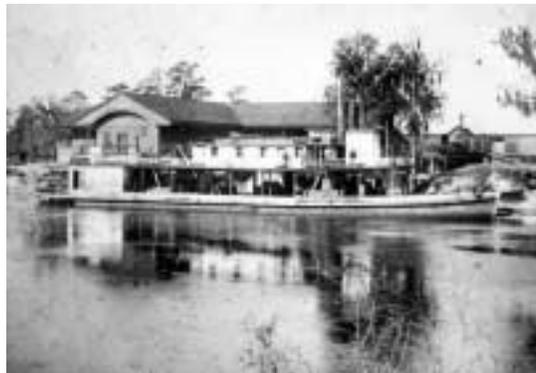
Figure 1: *City of Hawkinsville* docked - Photo Courtesy of Florida Photo Archives

Presently, the *City of Hawkinsville* sits on the limestone bottom of the Suwannee River on the Dixie County side of the river. Sometime after the boat sank, the upper deck was removed. She is lying on her starboard side, exposing the planking and main deck. The engine components remain on the vessel, providing an excellent example of late 19th century technology. When tannic levels and water stages are low, the *Hawkinsville* provides SCUBA divers an excellent dive. In 1989, Mike McCaskill nominated the *City of Hawkinsville* as a state underwater preserve. It achieved that status in 1991 and remains a popular attraction for divers who visit the Suwannee River (Horrell 2000: 2).

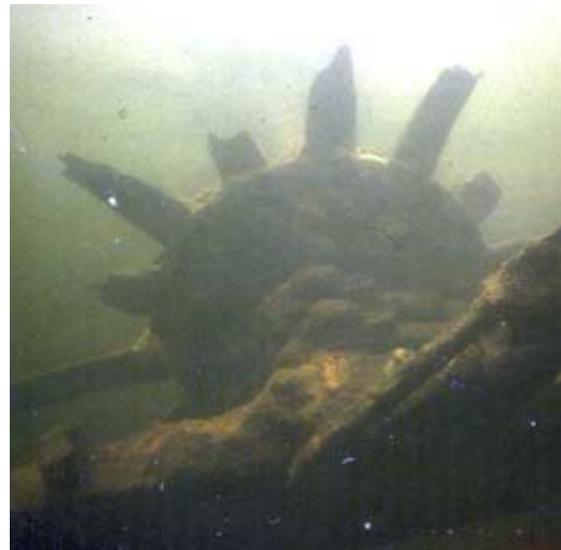
The paddlewheel spokes were measured for the first time since 1990. These measurements will be used for future deterioration evaluation. Divers measuring the spokes of the paddlewheels measured from the outer edge of the hub to the tip of the spoke. The divers started at the starboard side of the most starboard hub. They started with the spoke nearest to the 12 o'clock position and worked clockwise, labeling all spokes with corresponding clock position. However, the divers did not know how many spokes were on each wheel, and their turned out to be more than 12. The mylar data sheets show this as spokes are numbered 12, 1, 2, ... 11, 12, 13. The divers noted the exposed wood on the top of the hubs had suffered the worst damage and those on the bottom and away from the wreck had survived longer and showed less damage from impact current driven debris.

Spokes measured from outward edge of hub to end of remaining spoke. (measurements in inches)				
	Port			Starboard
12 o'clock	4.5			10
1	6	1	4.75	10
2	6.25	5	4.25	4.5
3	12	10	6	6.25
4	6	8	61.5	6
5	11	46	43	7.5
6	11	14.5	7.25	7
7	7.25	8.5	40	8.5
8	41	14	37.25	11
9	38	64	12	26
10	22	7.25	6	66
11	6	6	11.25	6
12	7		9	12
13			4	4.5

Figure 2 – Paddlewheel hub and spokes
