**REPORT ON THE SHIPWRECK AND
BIOLOGICAL SURVEY CONDUCTED ON
THE COAST OF FLEMMING KEY
MARCH 10-12 2001**

Research Reports # 12

Program in Underwater Archaeology
Florida State University
Department of Anthropology

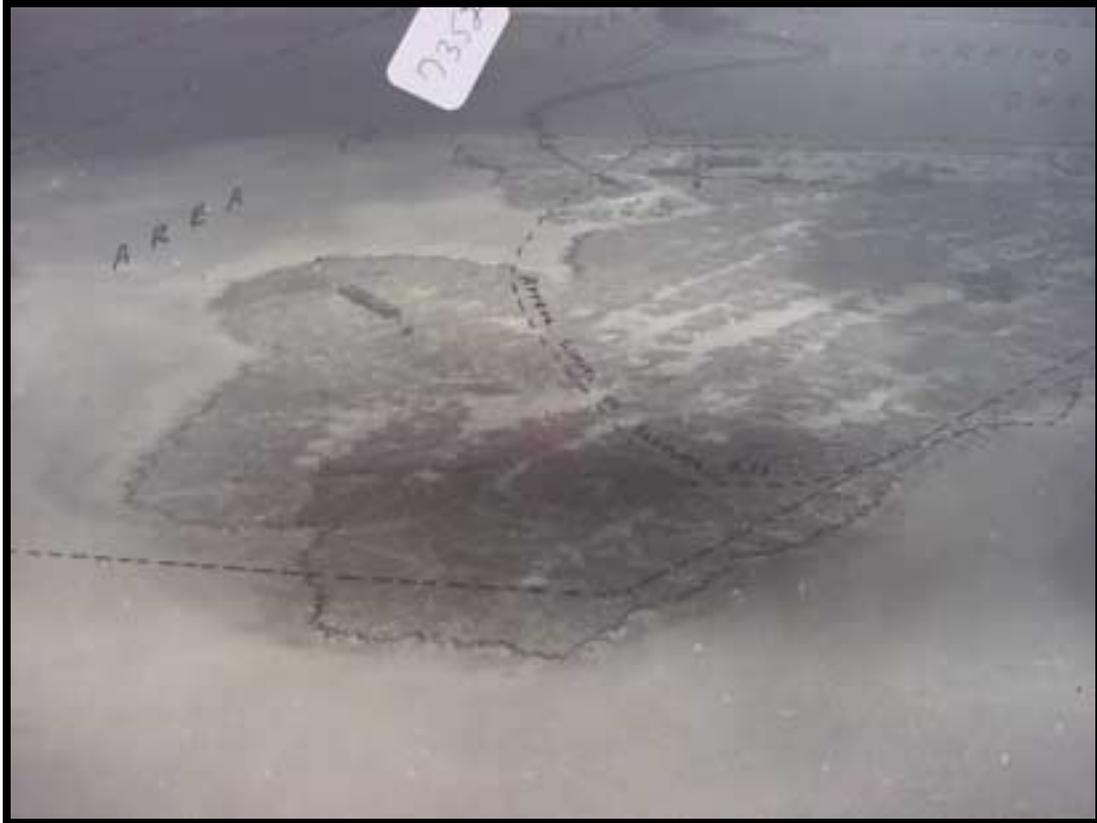
Figure 2: Naval photograph of Flemming Key before dredging 1941.

Originally Flemming Key was an uninhabited, low-lying marsh plain (Figure 2). Between 1941 and 1942, the United States Navy dredged sand surrounding Flemming Key, widening and deepening the channel for better access to Key West Naval Air Station. Sand was deposited on Flemming Key, extending the length of the key but also decreasing its width.

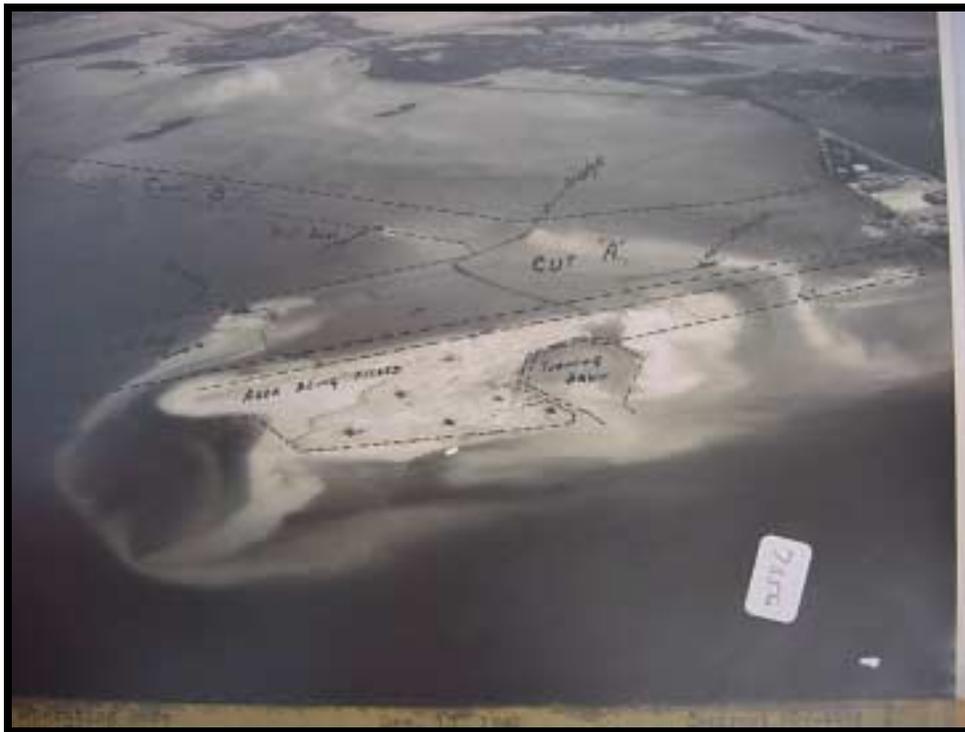
Figure 3: Construction of Flemming Key December 1941.

The Flemming Key wreck, FKNMS G3001, is located on the west side of the northern tip of Flemming Key, a manmade key constructed from 1941 to 1942 using fill dredged from the surrounding Man of War Harbor area (Figure 3). The key is the property of the Key West Naval Air Station and the wreck lies on base property. Portions of the wreck are exposed from the water and the bottom slopes down to 3 m deep. The wreck slopes downward to the northwest and low tides expose more of the wreck throughout the day.

Tom Hambright, an archivist in the Key West library and a former naval officer previously stationed in Key West, was instrumental in attempting to determine when the wreck first appeared on Flemming Key. Hambright also knew many of the local names for the Flemming Key wreck including the “Snook Wreck.” At certain times of the year snook can be found on the wreck where they are difficult to find elsewhere. Many people also call it “Little Schooner,” although it is unknown if it is a term for a rigging type or simply a name for a common type of ship. Hambright had no recollection of the wreck being mentioned in any newspaper articles, books or documents in the library. He was also sure that the wreck had not appeared on the key until after the construction of the key, which ended in 1942. In pictures from 1941 (Figure 3) and 1942 (Figure 4) the wreck is not evident giving a post date of at least February 14, 1942.

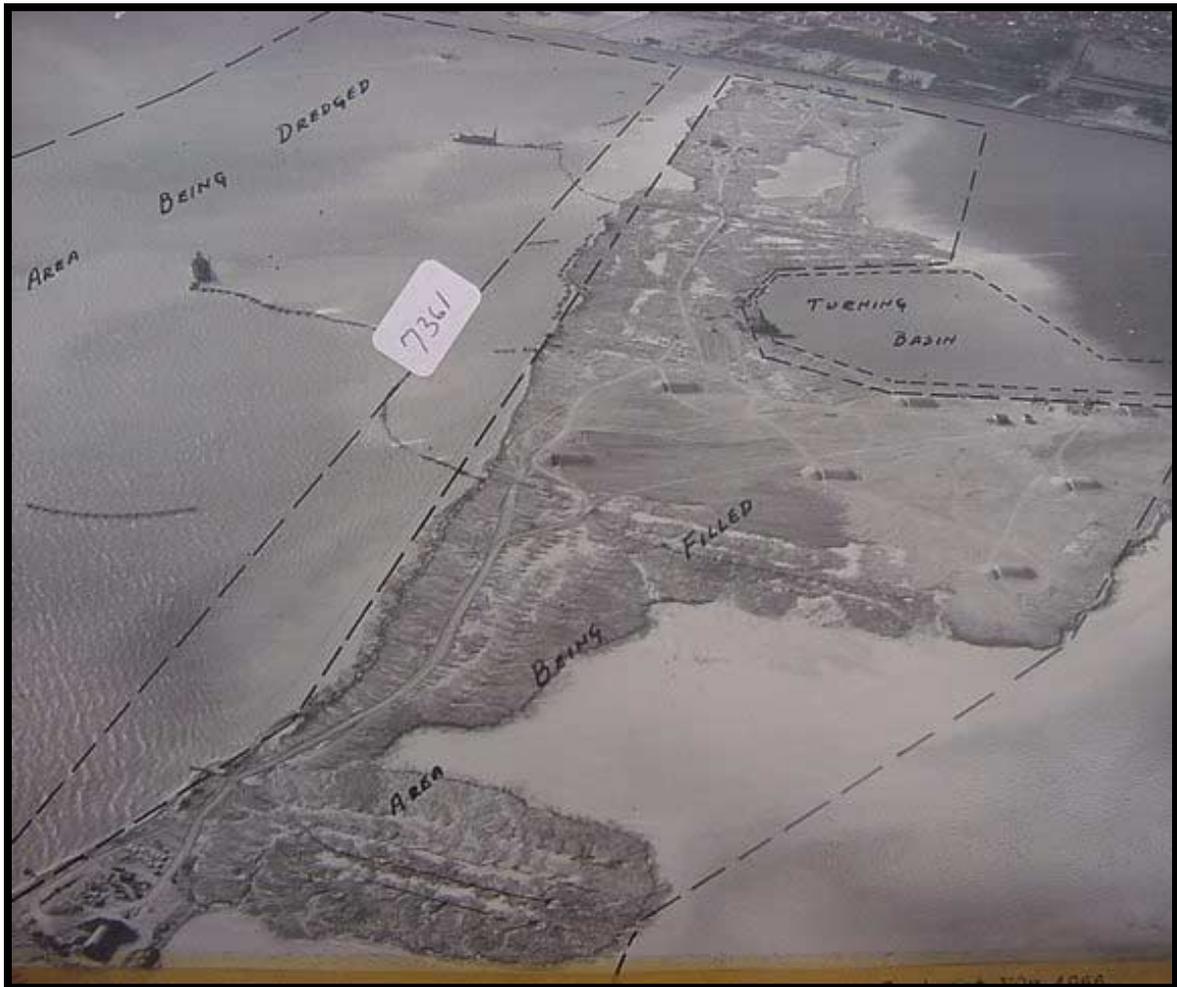
Figure 4: Naval photograph of Flemming Key, February 14, 1942.

It is clear from the dramatic geomorphologic change of Flemming Key from 1941 to 1942 that no wreck could have survived the dredging activity intact. This high degree of disturbance suggests that the ship must have appeared after completion of the key and February 14, 1942 is the last photograph available of the construction (Figure 4). Although Naval photographs are taken at a high elevation and distance, the Flemming Key wreck is clearly not present in any of the photos of the construction.

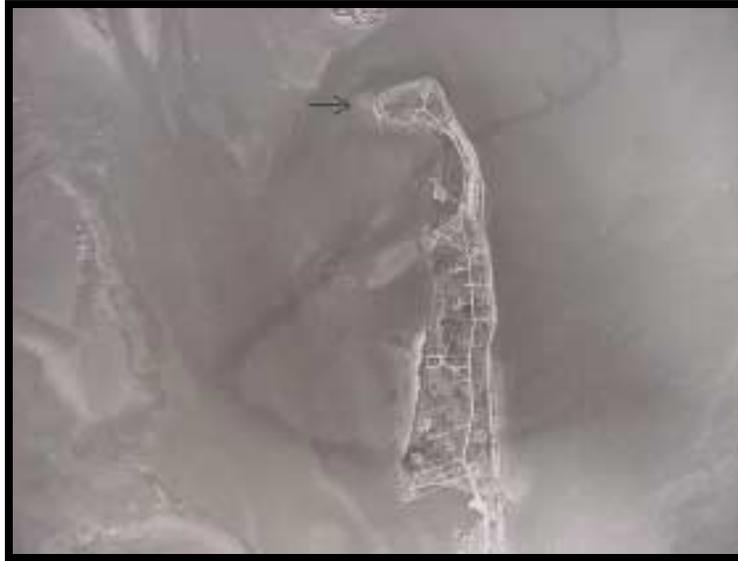
Figure 6: Department of Transportation Aerial Photograph, 1959.

Reginald Bradley, Department of Transportation Aerial Survey Division, provided photographs of Flemming Key from 1959, 1963, 1971 and 1998. The earliest photograph provided, February 22nd, 1959, clearly has the wreck lying off of Flemming Key (Figure 6). The wreck was also clearly demonstrating the hull slippage observed indicating that hull degradation had been occurring for some time previous to 1959. This photograph provides the necessary predate for the appearance of the wreck on Flemming Key. The wreck and the associated sediment accumulation can be seen in the close-ups in Figures 7-10. The wreck arrived on the northwest shore of Flemming Key sometime between February 14, 1942, and February 22, 1959 an 18 year range.

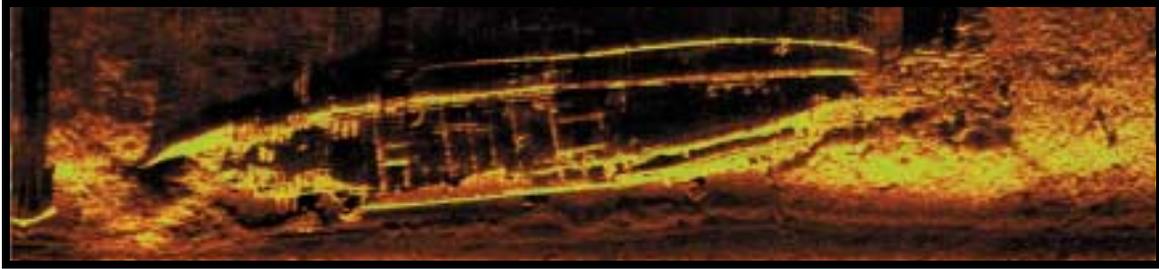
Figure 11: 1998 side scan image of the wreck

There are two hatchways visible in the aerial photograph (Figure 12) and in the side scan image from 1998 (Figure 11). These hatchways are 11m 53cm apart and the larger one is located directly behind a circular structure in the middle of the ship, see site map (Figure 18). This large circular structure, which is bent and twisted now, is 56cm in diameter and is possibly a casemate for a mast or smokestack. A conglomeration of long pipe like remains approximately 7 m to the west of the ship and have a diameter of 50cm, these may be the remains of a mast or smoke stack (Figure 14). It is still unknown what it is or if it is even associated with the wreck, but it may be that the structure may have fallen off or been removed and later settled there.

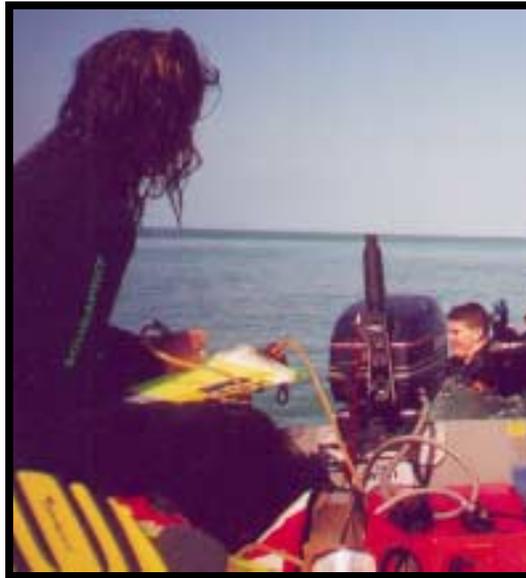
Figure 13: Zuleyha Gokay and Brian Dean taking measurements of the wreck

SCUBA operations were conducted on the wreck each day with support by several students on snorkel. Two dives were devoted solely for the biological survey on March 11 and 12. To map and survey the wreck accurately a temporary baseline was laid on each dive with metric measuring tape. This baseline was measured off of to determine the dimensions of the ship and relationships to various features and structures within it. To determine the overall length of the ship and the remaining outline; offsets were taken every 5 meters to a stringer on each side. The length of the wreck above the sediment is 42m 20cm, (138ft 5in), although the complete length remaining beneath the sediment is unknown.

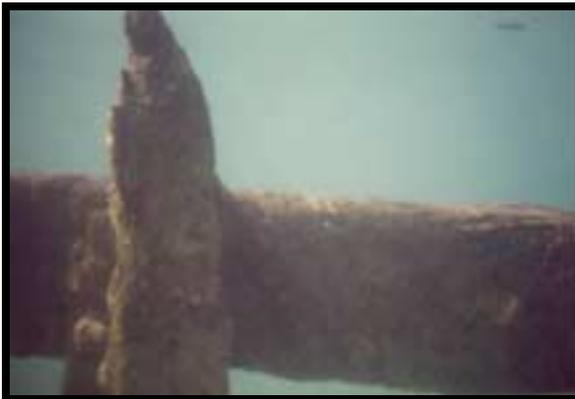
Figure 15: The frames underwater

The middle of the ship was identified by the change in the placement of the frames and the width at amidships was measured at 9m 80cm (32ft 2in). The frames north of this point are “facing” one way and then at amidships an aberrant frame occurs (possibly the main frame), then all “face” the opposite direction for the rest of the ship (Figure 16). This is the clearest evidence observed to determine the middle of the ship given that both ends are disarticulated. The bow probably faced north since structures that appear to be haws holes are still present in some of the remaining deck structure. The placement of the hatchways also seems to be in a typical pattern with the larger one around amidships (Figure 18).

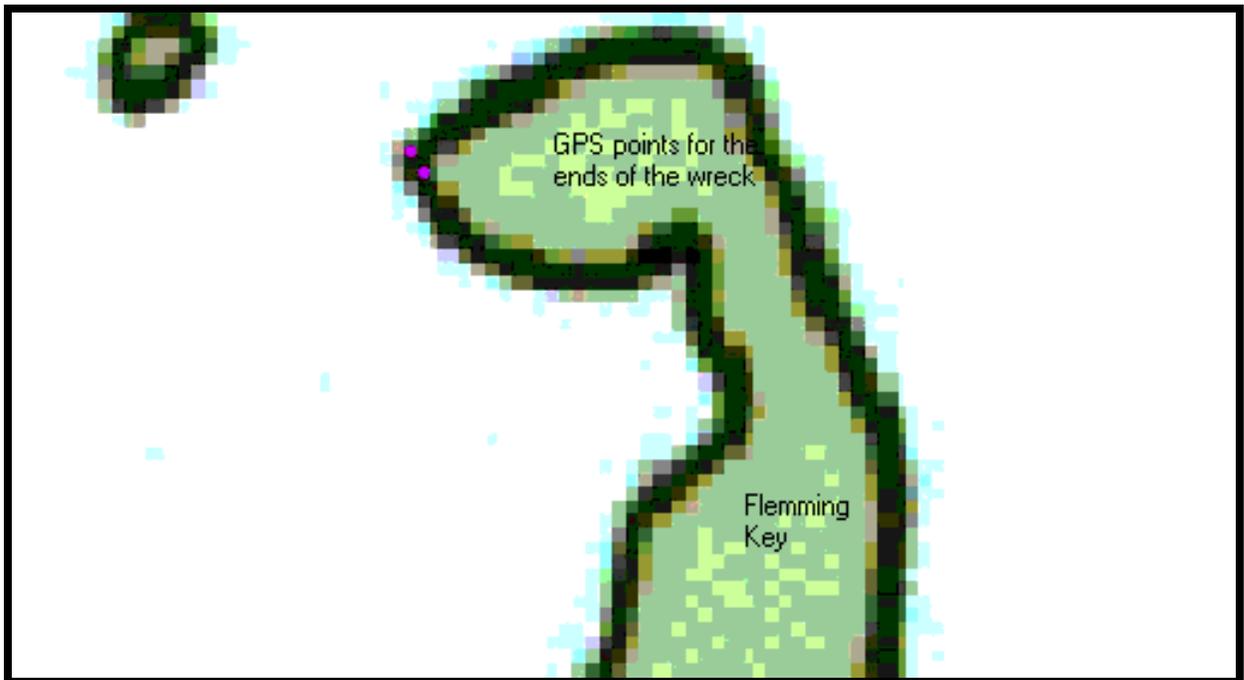
Figure 17: GPS readings of the ends of the wreck

No excavations were conducted to find the keel or any other structure below the sediment. The original length of the wreck could not be determined because much of the wreck is buried in the sediment. Two GPS readings were taken by a swimmer over each end of the wreck using a Lorance Globalmap100 12 channel receiver and plotted in to an ARCVIEW map (Figure 17). The measurements from the GPS do not correspond to the overall length determined by direct measurements of the wreck because of inherent inaccuracies of the GPS system.

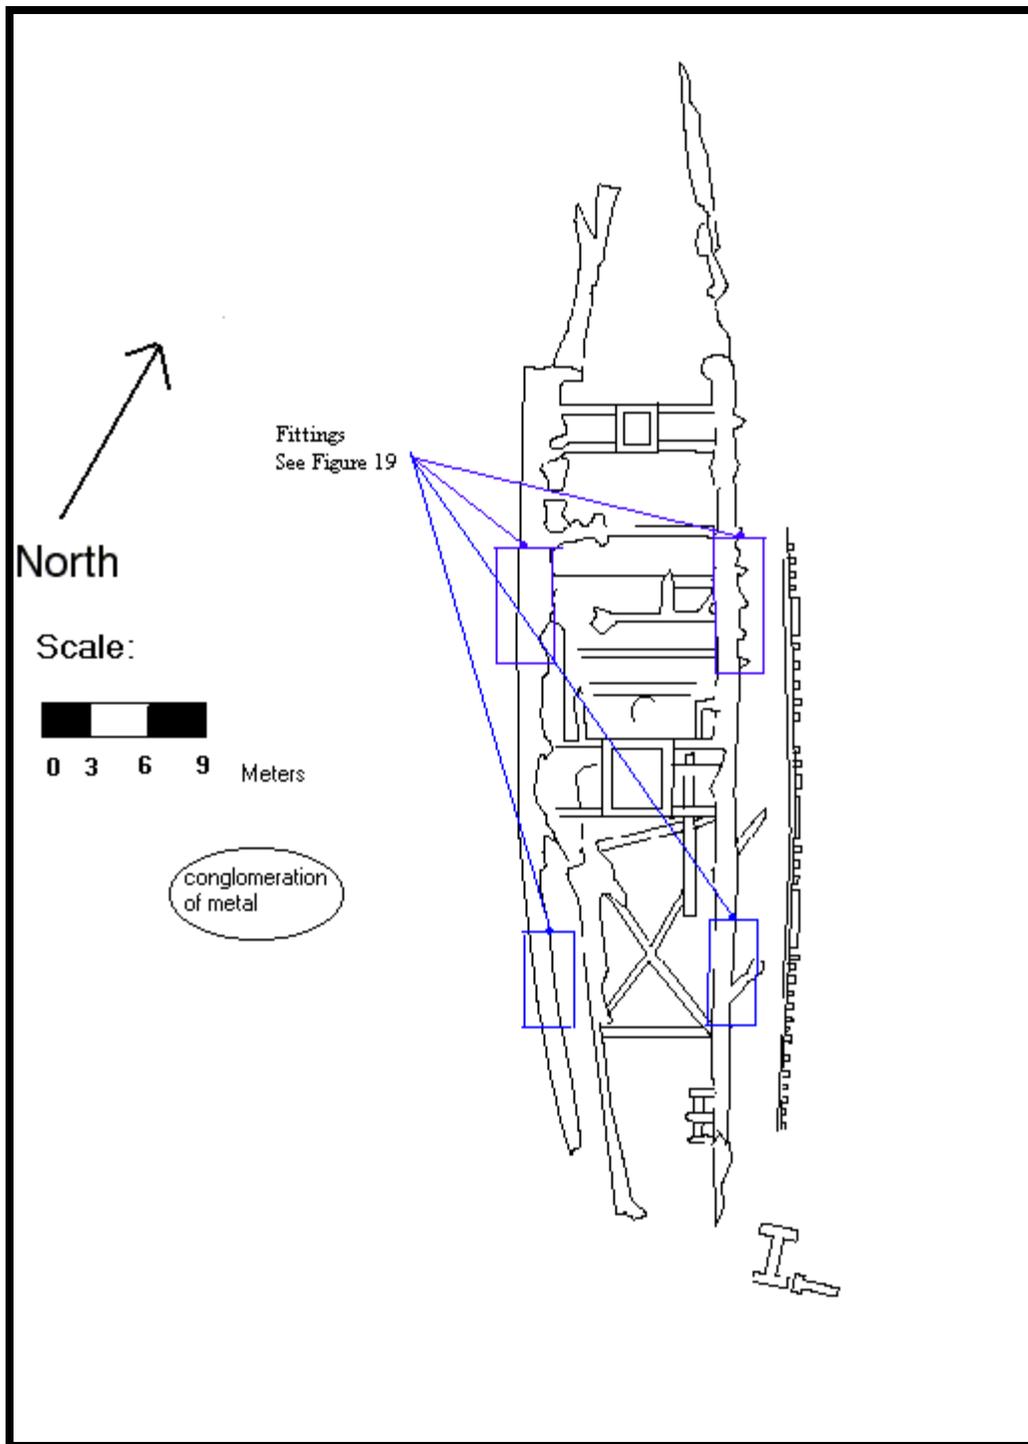
Figure 18: Site plan of the wreck

A boiler was reported in the 1998 FSU field report as possibly being associated with the wreck, but that is unlikely given the other evidence for a sail and its distance from the wreck at 7.5 meters. The boiler may have been used to lift the sails or anchors. Further analysis is required to determine its association with the wreck. A copper plate was also analyzed in the 1998 survey and replaced on site. It was from a truck transmission, which makes the association ephemeral at best. The ship was built with a steel hull and riveted together unlike modern steel ships, which are welded, indicating its age.

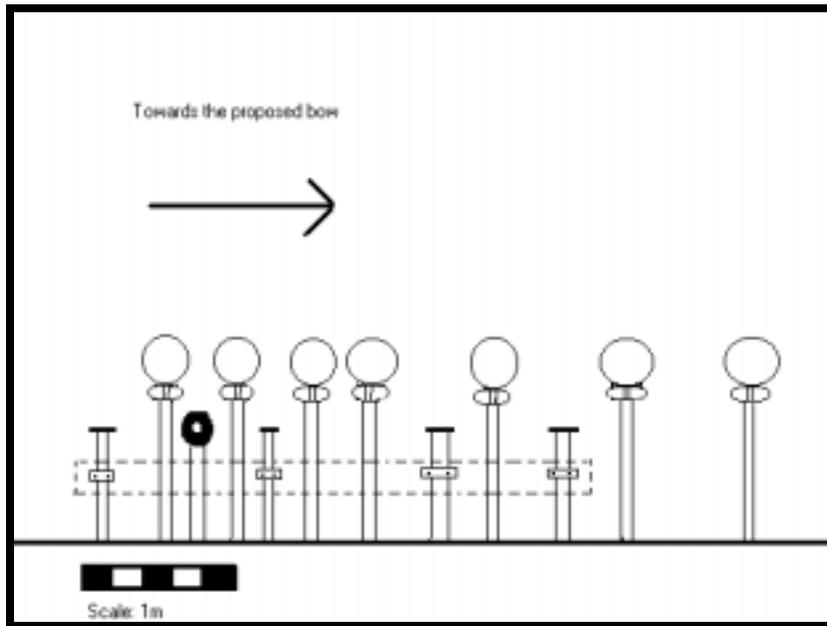
Figure 19: Fittings

There are four sets of fixtures protruding from the wreck, possibly standing rigging, each of which are constructed of standard shapes and sizes and have been reconstructed in Figure 19. Only the most forward set on the proposed starboard side is out of the water, and all are in various states of degradation. The original planking of the ship is unknown, but it is likely that it was a wooden deck. The upper deck planking is missing but various bolts measuring approximately 5cm high protrude from the crossbeams. Wood may have been attached by the bolts and supported by limited steel decking.

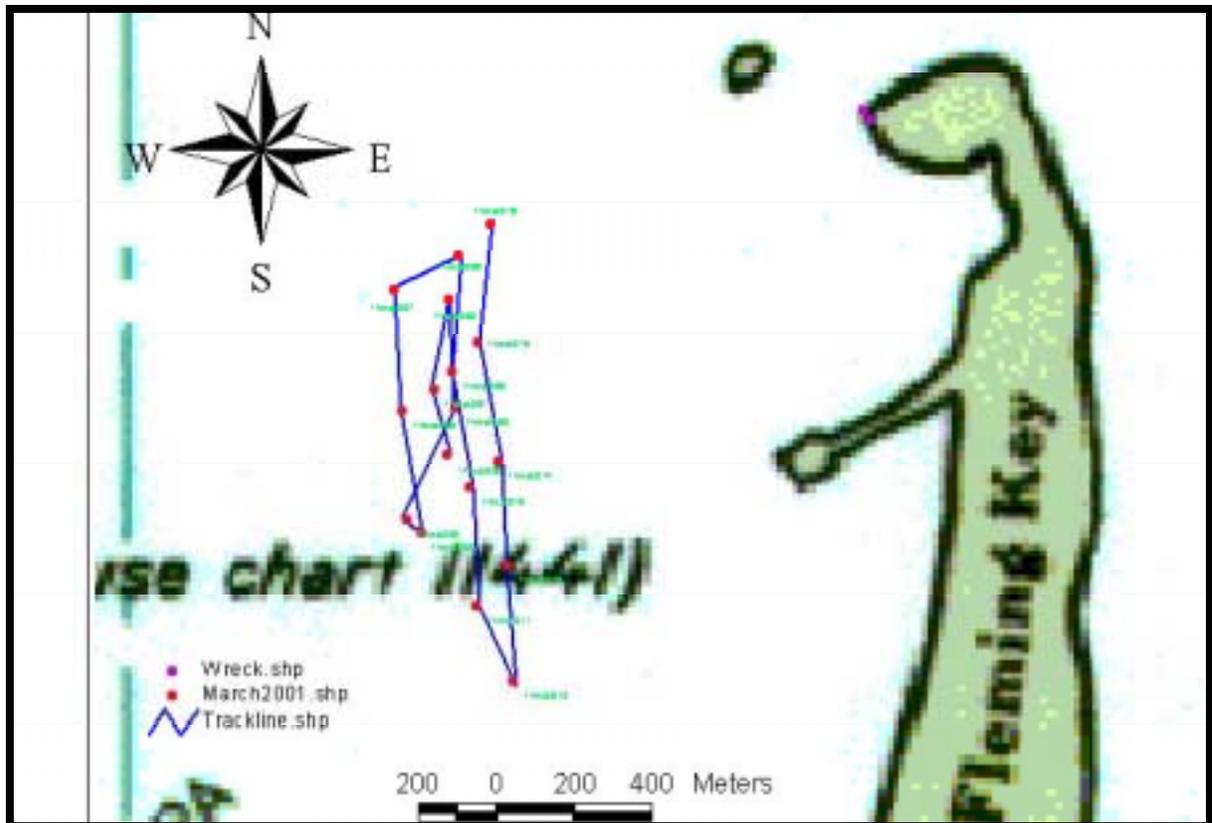
Figure 21: Sidescan tracklines

On March 11 a limited side scan survey was conducted using the Marine Sonics Splashproof Seascan PC with a 600 kHz towfish onboard the Boston Whaler provided by the R/V *Bellows*. The survey was undertaken to determine the functioning capabilities of the unit after a recent repair and to familiarize students with its operation. The range was set to 75 meters with the line spacing at 125 meters (Figure 21). The Lorange Globalmap 100 12-channel receiver tied into the PC maintained the GPS control for the survey. The side scan data was not studied and is stored in the George R. Fisher Underwater Laboratory at Florida State University.

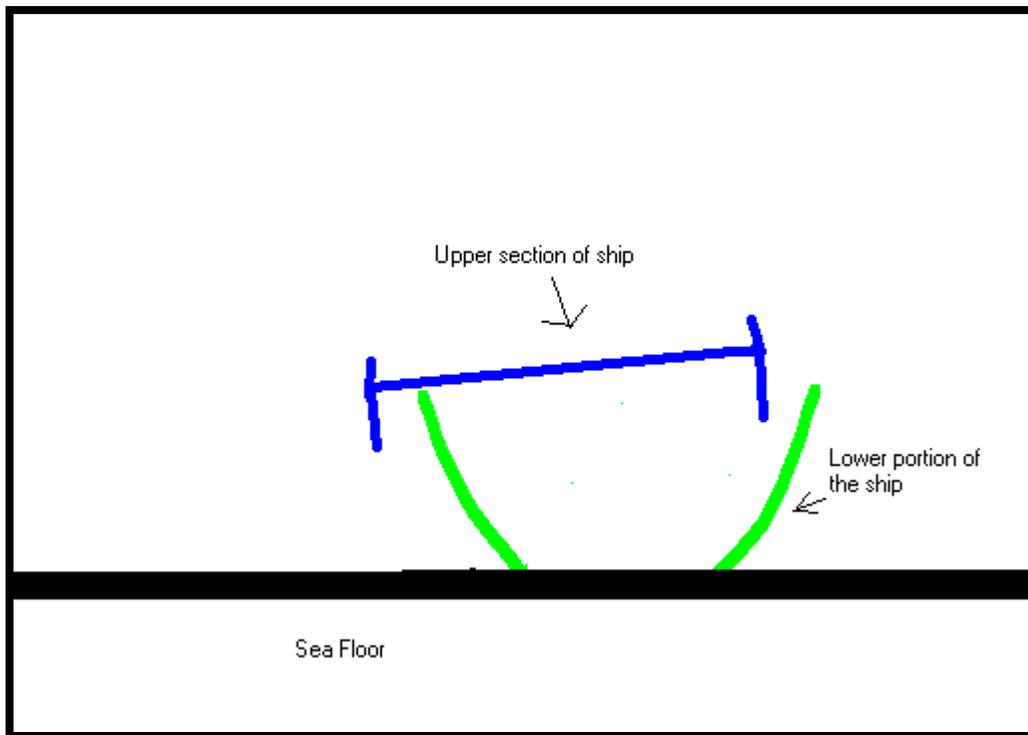
Figure 23: Upper hull slippage

The present working hypothesis for the Flemming Key wreck is that it is a steel hulled sailing ship that sits on the seafloor listing slightly to port running aground sometime after 1942, possibly in a major hurricane in 1948. It is still unknown why the ship sank, intentionally or accidentally, or even what the name of the ship is. The tidal action of the saltwater drying out and soaking the metal at the waterline corroded away the steel along the side closest to the sea and significantly weakened the corresponding side. When the weight of the upper deck structure became too great for the corroded sections to bear the entire upper deck structure sloughed off in one piece (Figure 11). The deck beams that once supported the deck, held the sides together as the upper portion separated from the bottom of the hull. The bottom hull in contrast appears to have remained in a relatively unchanged position.

The condition of the shipwreck has apparently remained stable from 1959 until 2001, indicating that it is not in immediate danger of disintegration. Below the waterline the steel of the ship seems to be remaining intact, possibly because of the algae growing on it. The United States Navy technically owns the wreck, and Navy policy dictates a close regulation of its property. This tight control is not occurring however, since the ship is littered with trash, beer bottles, buckets, and other various debris. The traffic on the wreck by divers and fishermen is having an impact on the wildlife in the area, however further study is required to determine how much that impact is.
